# Inspection Report

**CRAFTSMEN**  
**HOME INSPECTION SERVICES, LLC**

1234 Comfy Lane Somewhere, New York 14111

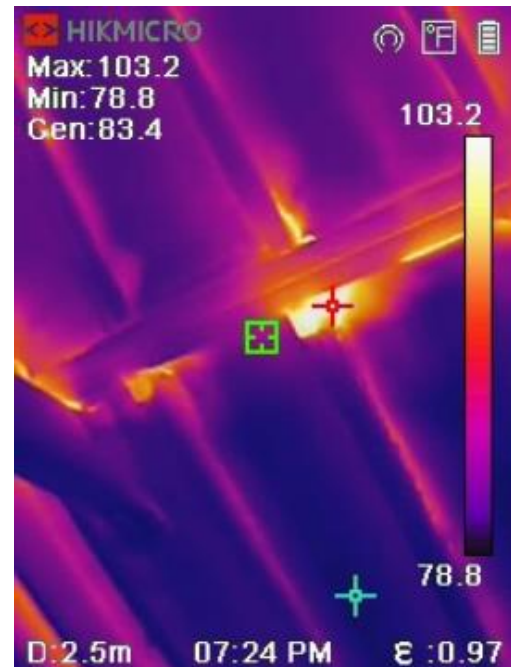
### 1.7 Attic Insulation Conditions (Monitor)

The spray foam insulation appears to be generally in good condition. There is one area where the insulation appears to be compromised. In its present condition, the insulation in this one area is not functioning as designed.

Note foam material is not attached to the structure.  
Exterior heat is able to penetrate into the attic space.

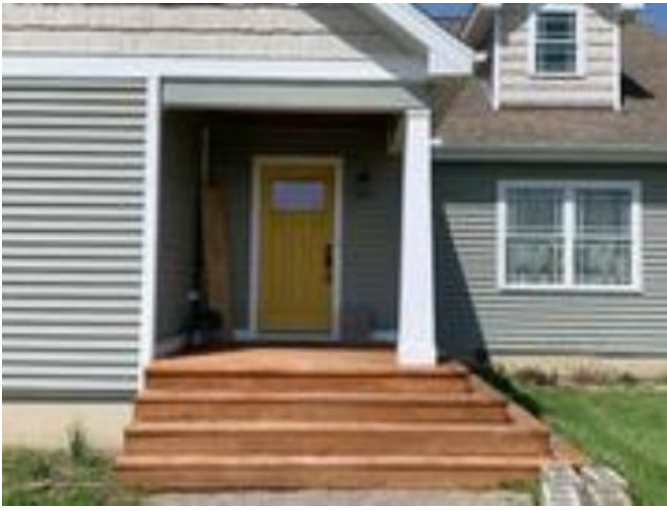
### 2.1 Front Entrance Conditions (Safety)

There are no railings on the front porch. In its present condition, an unsafe situation is present. Seek advice of a contractor to evaluate. Also, both front porch areas have stain in need of attention. In its present condition, bare wood is exposed to the elements, and the structural integrity of the wood is compromised. Consider applying a fresh coat of stain or consult a painting specialist.

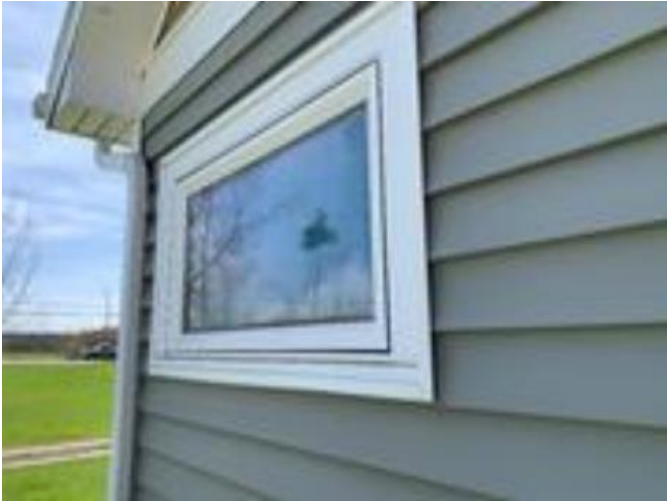
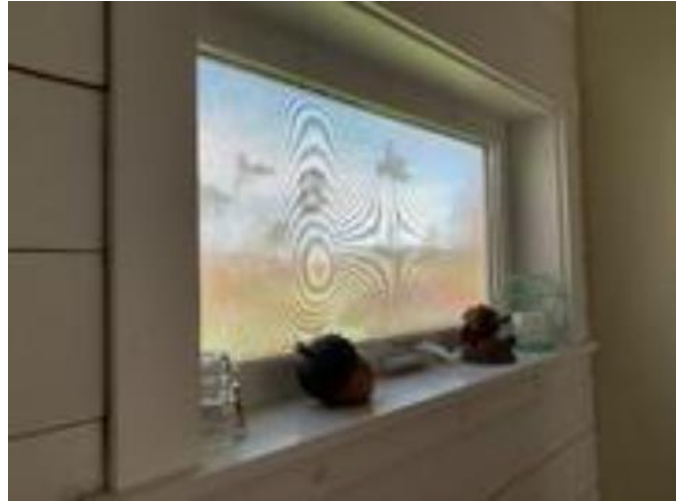
## 2.4 Window Conditions (Repair)

The seal is broken on this awning window. In its present condition, the home's energy efficiency is affected. This also affects visibility. The seal is also broken on the front window. In its present condition, the home's energy efficiency is affected. This also affects visibility. Seek advice of a window specialist.

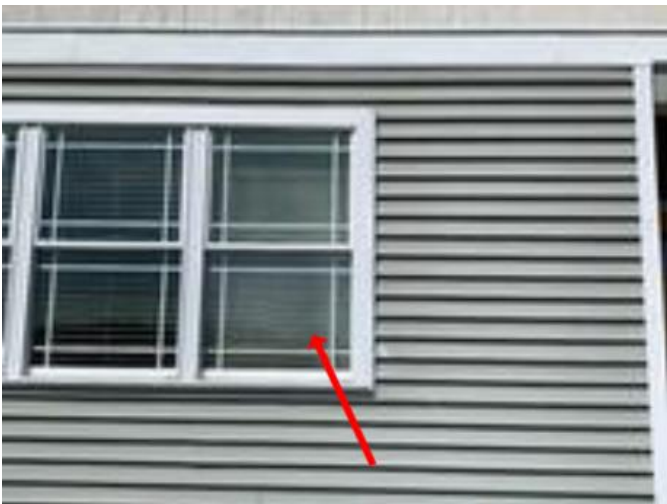
The lower right front window has a broken seal.

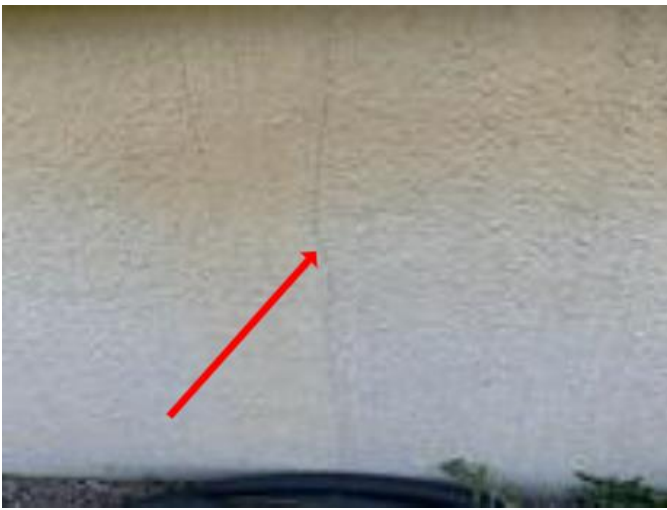
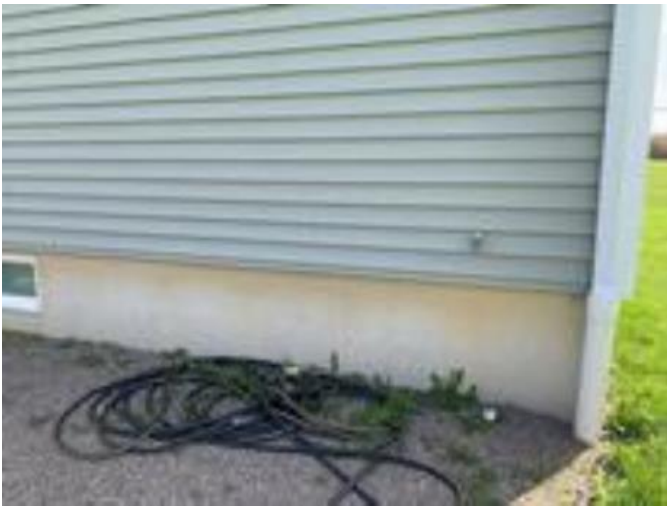
### 4.1 Foundation Conditions [\(Monitor\)](#)

Small minor cracks There are some minor hairline cracks in the foundation. Normally hairline cracks are not the result of foundation failure. These cracks provide an area for water penetration. Monitor and seek the advice of a qualified foundation specialist if necessary.

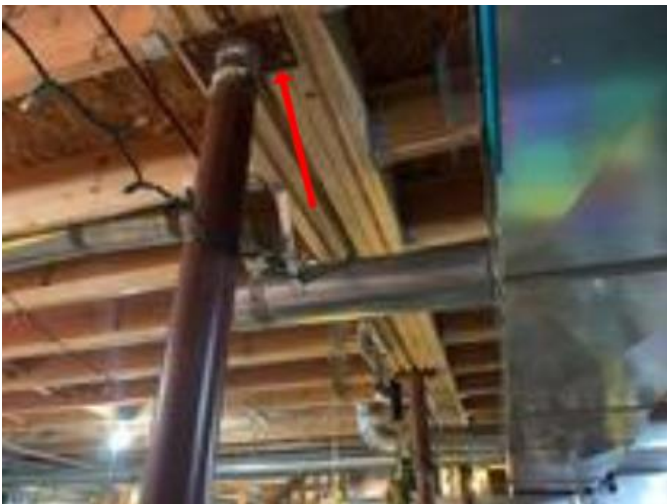
#### 4.2 Flooring Support Conditions (Repair)

The main support posts are not fastened. A basement post exists to support the main beam so it does not sag under the weight of the entire structure. Seek the advice of a qualified contractor for a permanent way of fastening.

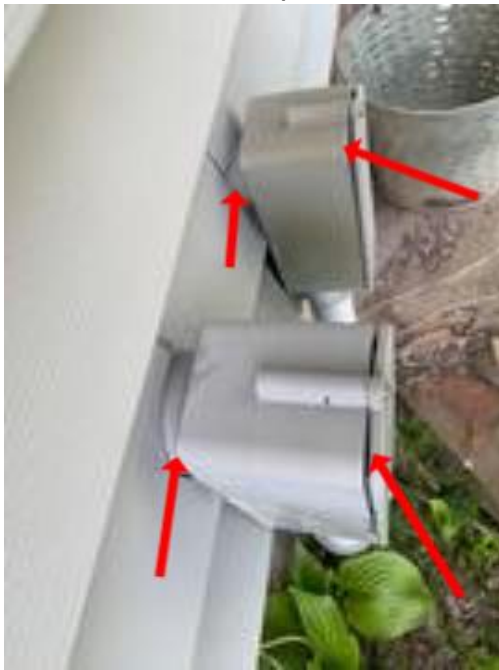
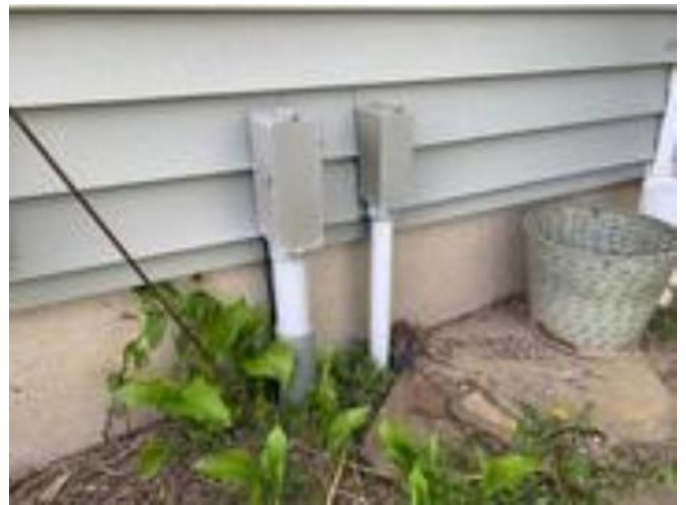
### **6.1 Electrical Service Conditions (Safety)**

The electrical conduit LB fittings have damaged gaskets and no seal at the vinyl siding. In its present condition, water can penetrate and cause a dangerous situation in the electrical service panel. Seek the advice of an electrician to repair as necessary.

Damaged gaskets and no caulking is allowing water to enter.

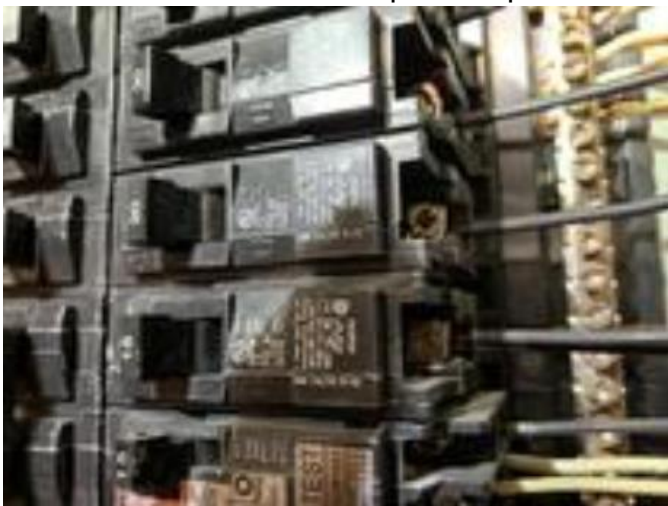
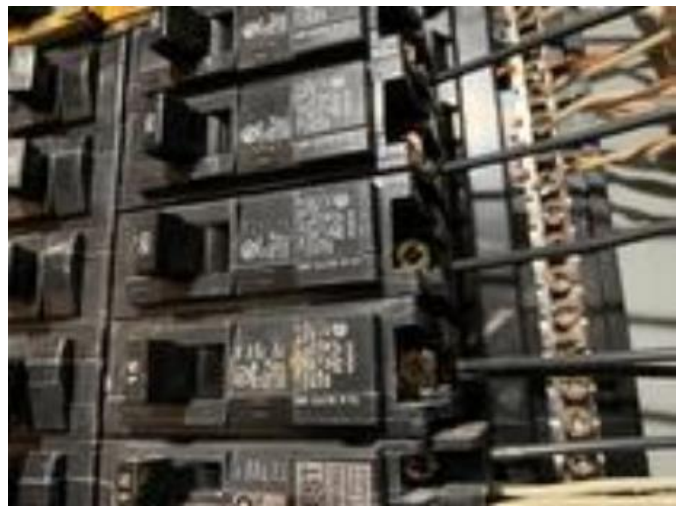
#### **6.4 Electrical Panel Conditions 2 (Safety)**

A 15 amp single pole breaker has two wires attached to it, which is unsafe. A single wire should attach to each breaker terminal. Multiple wires attached to the same terminal can become loose, arc, and create a fire hazard. Seek advice of a qualified professional electrician.

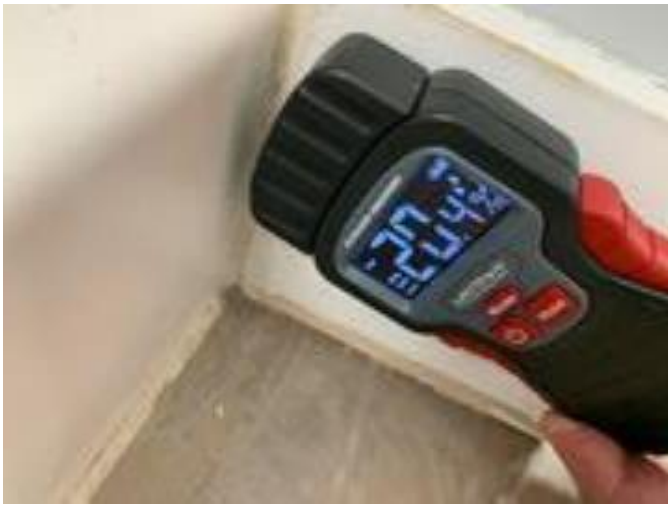
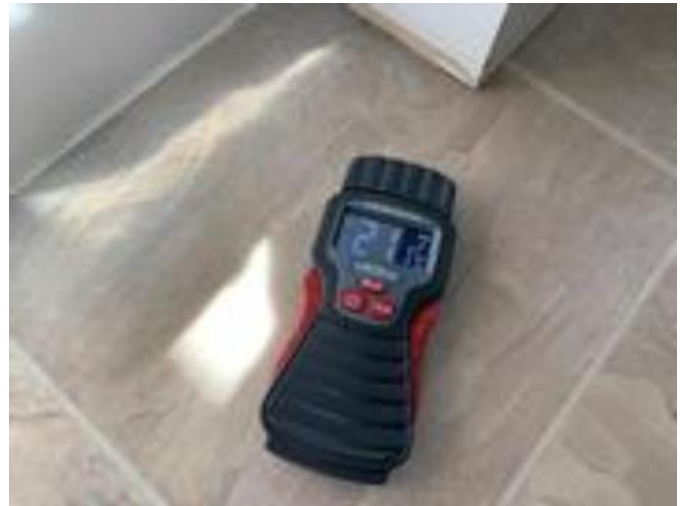
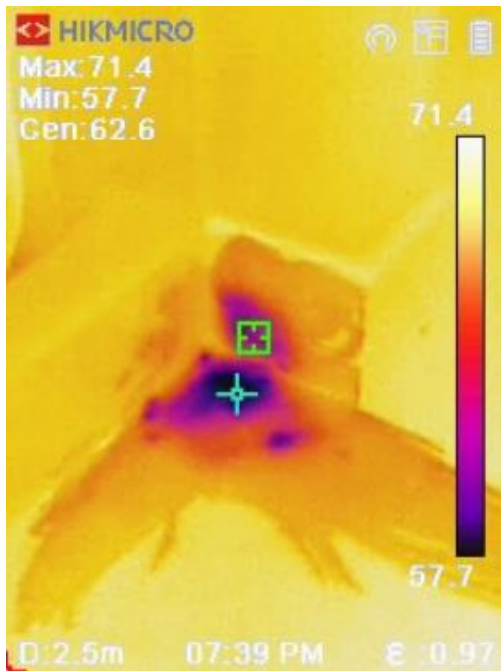
### 9.9 Caulking (Repair)

The master bath shower area has deteriorated and missing caulk. A thermal image was taken and the floor area was tested with a moisture meter and showed excessive moisture. In its present condition, the opportunity is present, over time, for damage. Seek advice to repair as necessary.
