# Inspection Report

**CRAFTSMEN**  
**HOME INSPECTION SERVICES, LLC**

1234 Comfy Lane Somewhere, New York 14111

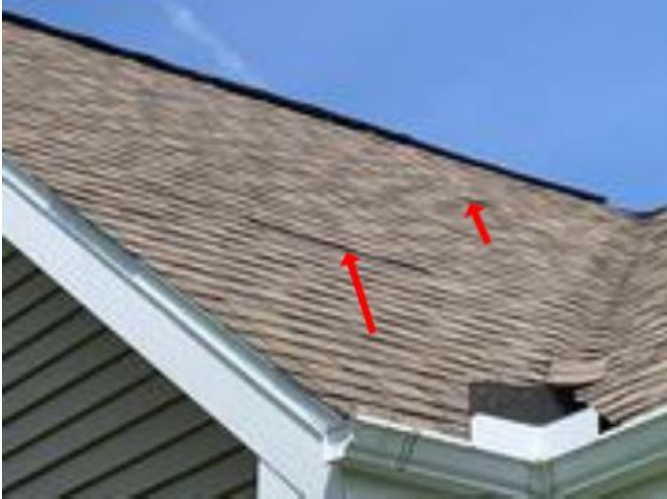
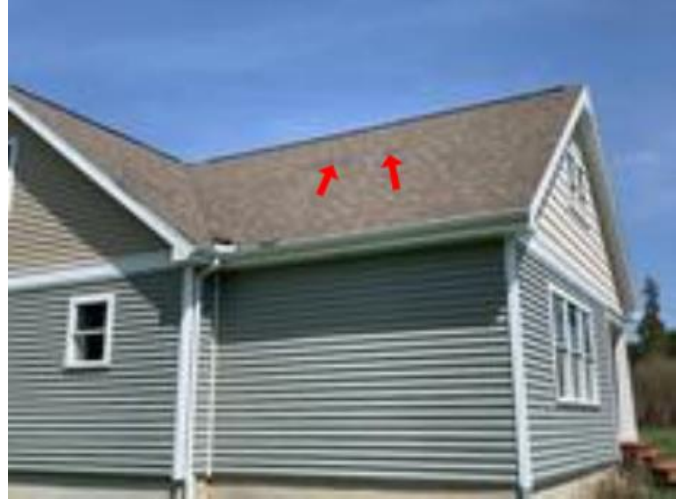
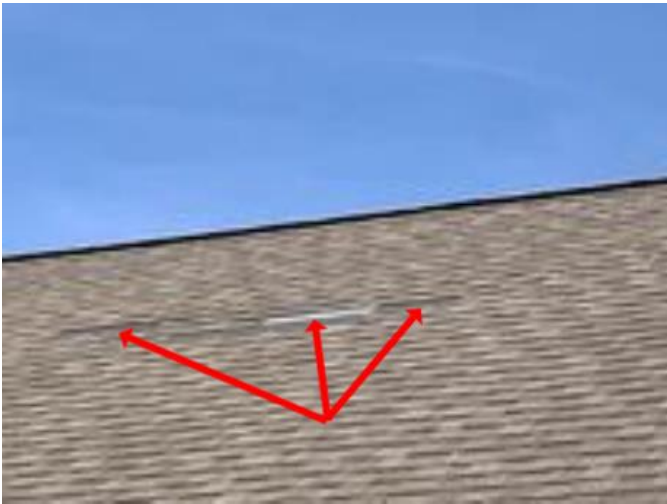
#### 1.1 Roof Covering Condition 1 (Repair)

There are areas missing roofing shingles. In its present condition, nails and underlayment are exposed. This allows for water penetration. Seek the advice of a qualified roofing specialist.

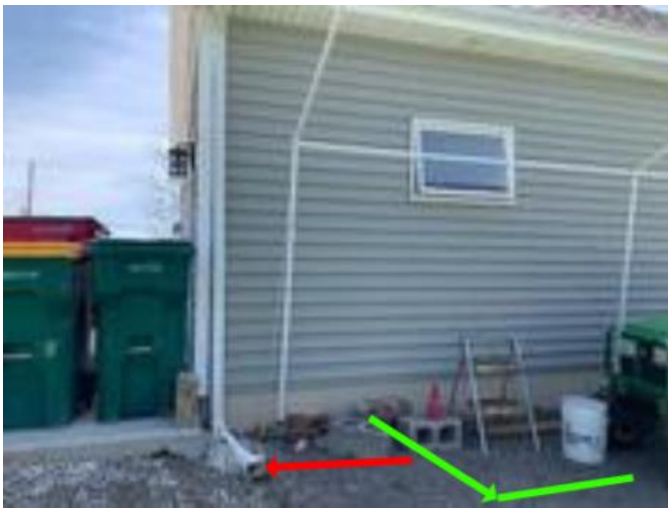
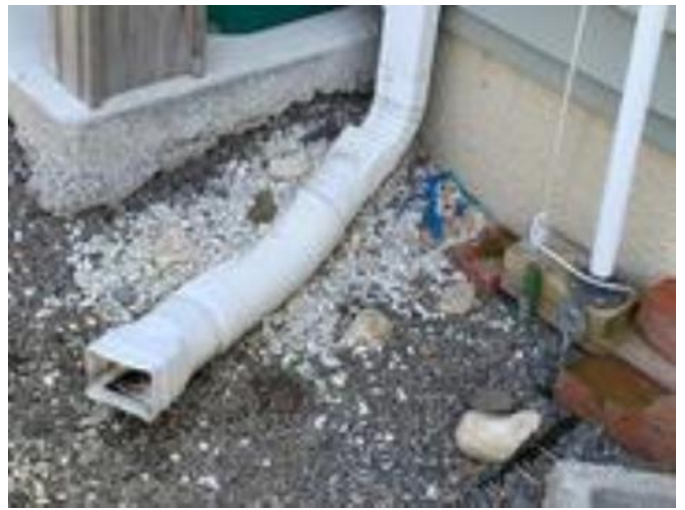
#### 1.3 Gutter & Downspout Conditions (Repair)

The gutter extension is not long enough. The purpose of the extension is to take water away from the home. In its present condition, water is eroding stone away from under the concrete drive. Seek the advice of a contractor to repair as necessary.

Rainwater should be directed further away from the house.

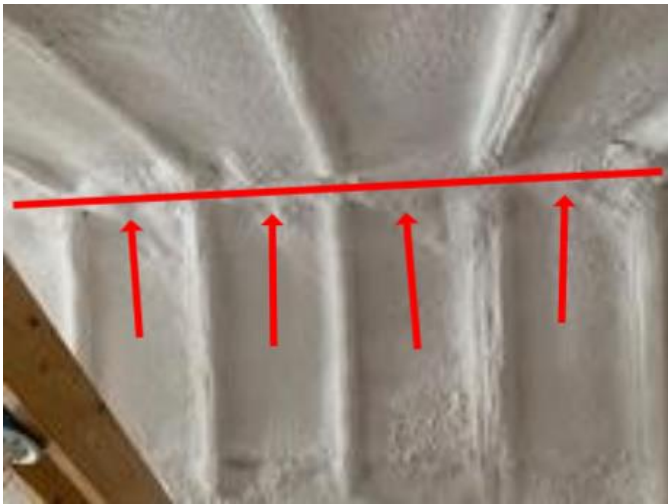
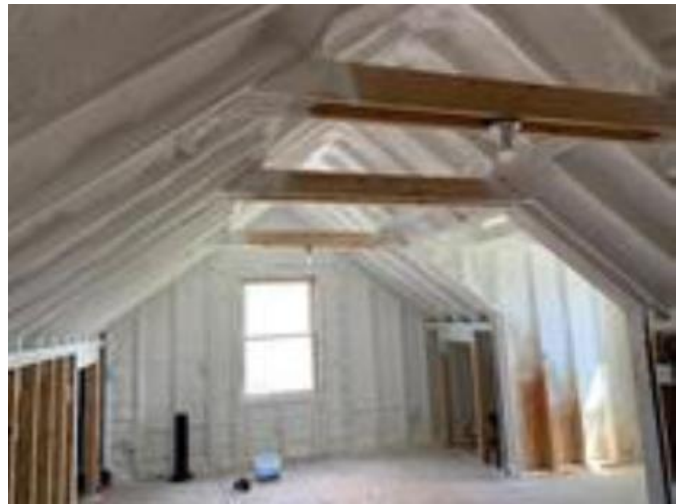
### 1.6 Attic Ventilation Conditions [\(Monitor\)](#)

The attic area is fully insulated with spray foam. The ridge and soffit vents are blocked. In its present condition, the air is not circulating and feels heavy. Seek the advice of an indoor air quality specialist to evaluate.

Note the ridge vent area is covered.

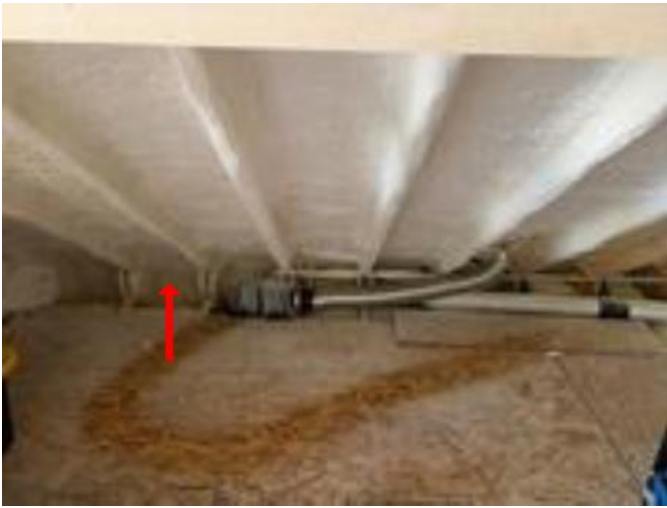
Note the soffit area ventilation is covered.

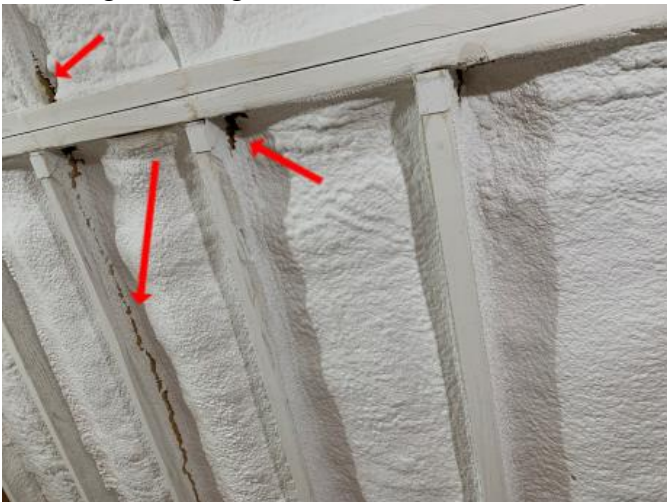
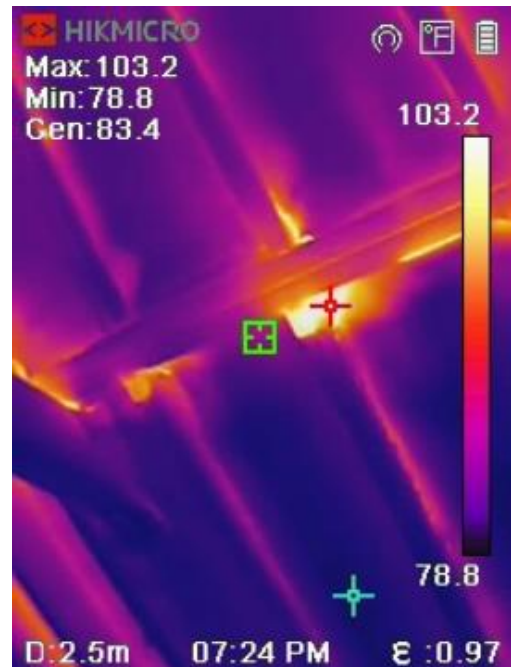
### 1.7 Attic Insulation Conditions (Monitor)

The spray foam insulation appears to be generally in good condition. There is one area where the insulation appears to be compromised. In its present condition, the insulation in this one area is not functioning as designed.

Note foam material is not attached to the structure.  
Exterior heat is able to penetrate into the attic space.

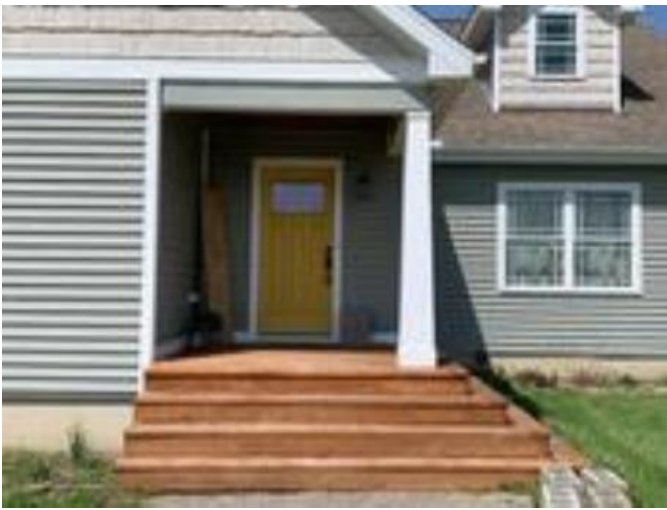
### 2.1 Front Entrance Conditions (Safety)

There are no railings on the front porch. In its present condition, an unsafe situation is present. Seek advice of a contractor to evaluate. Also, both front porch areas have stain in need of attention. In its present condition, bare wood is exposed to the elements, and the structural integrity of the wood is compromised. Consider applying a fresh coat of stain or consult a painting specialist.

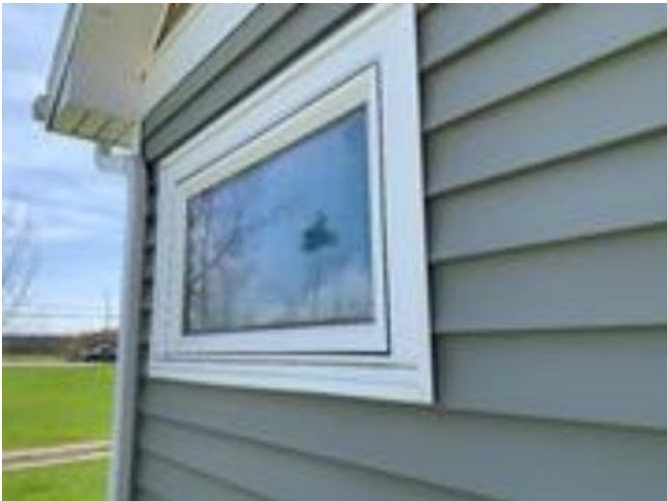
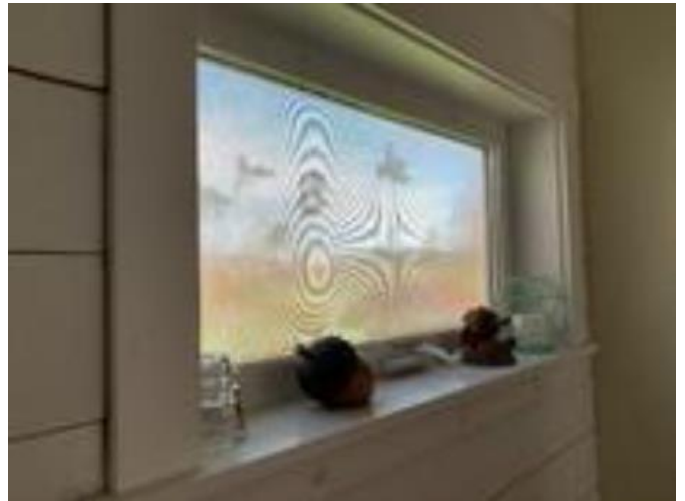
## 2.4 Window Conditions (Repair)

The seal is broken on this awning window. In its present condition, the home's energy efficiency is affected. This also affects visibility. The seal is also broken on the front window. In its present condition, the home's energy efficiency is affected. This also affects visibility. Seek advice of a window specialist.

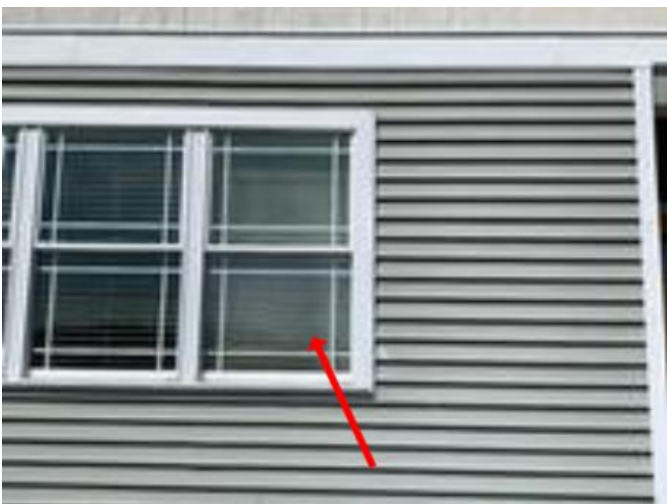
The lower right front window has a broken seal.

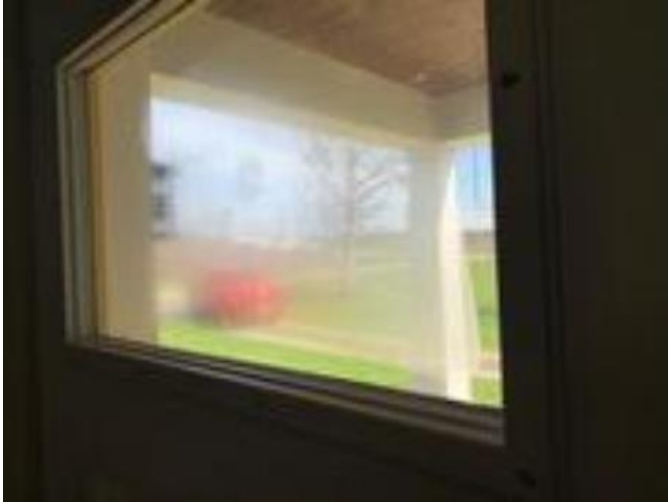
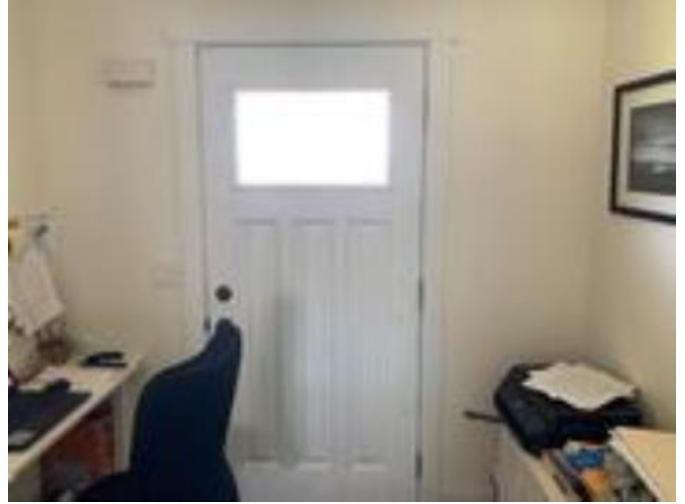
## **2.5 Exterior Door Conditions** (Repair)

The seal is broken on the main entry door window. In its present condition, the home's energy efficiency is affected. This also affects visibility. Seek advice of a window and door specialist.

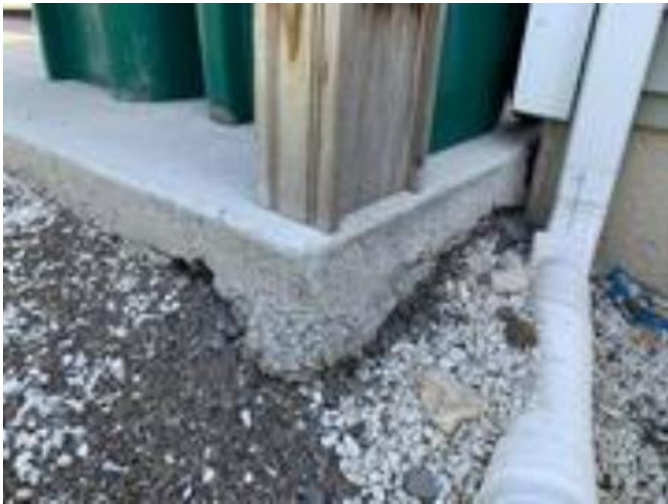
### **3.2 Driveway Conditions** (Monitor)

The stone base of the driveway is eroding out from under the concrete. In its present condition, the integrity of the driveway is being compromised. Seek advice of a qualified landscaper to repair as necessary.

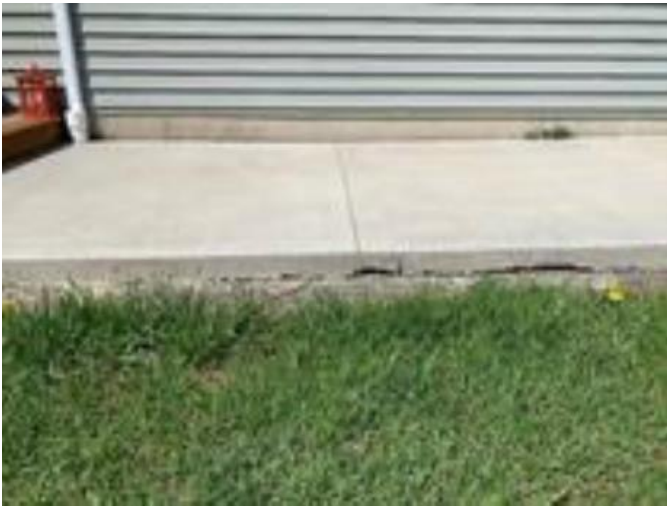
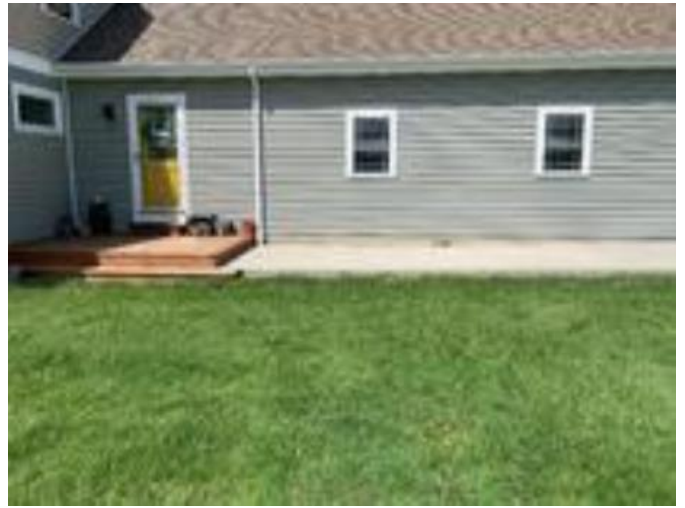
### **3.3 Sidewalk Conditions** (Monitor)

The concrete walkway is tilted toward the house. This allows for water to drain toward the foundation of the home. Monitor the basement area for water penetration. Seek the advice of a foundation specialist if necessary.

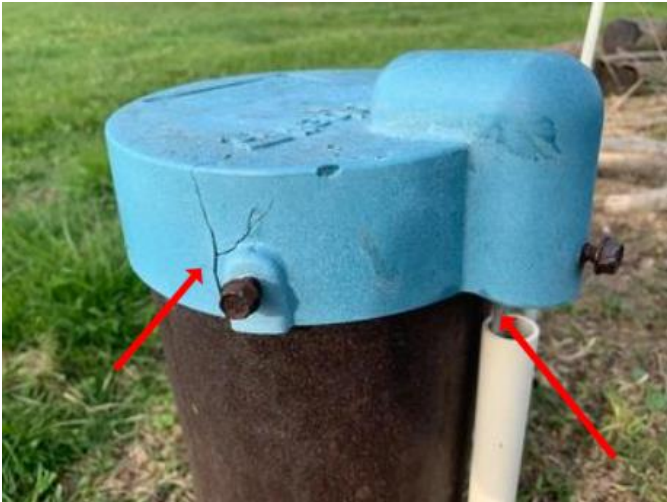
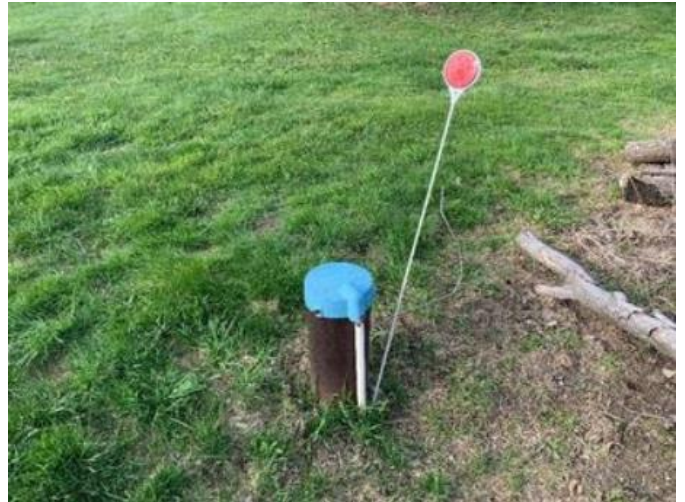
### 3.4 Well Head Conditions (Repair)

The well head cap is cracked and is a standard cap. You may wish to replace it with a sanitary cap. In its present condition, dirt, insects, and bacteria, is able to penetrate the casing cavity. Seek the advice of a well specialist to evaluate and replace as necessary. The wire sending power is exposed. The plastic conduit is pulled away from the cap. In its present condition, it may become damaged.

Crack noted on the well cap. Plastic conduit separated from the cap, exposing wire.

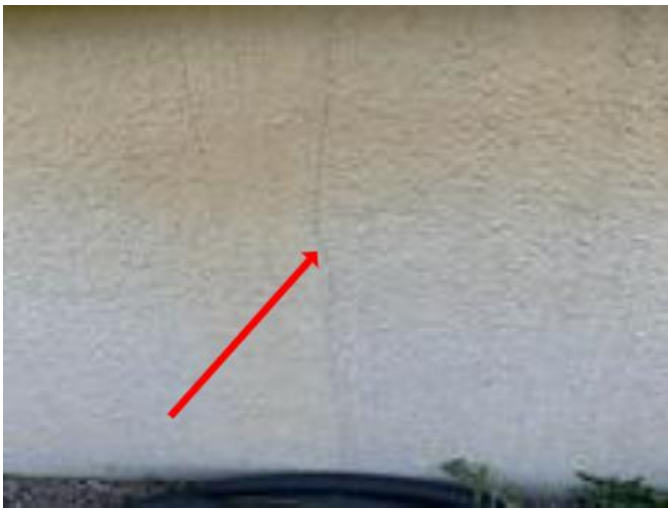
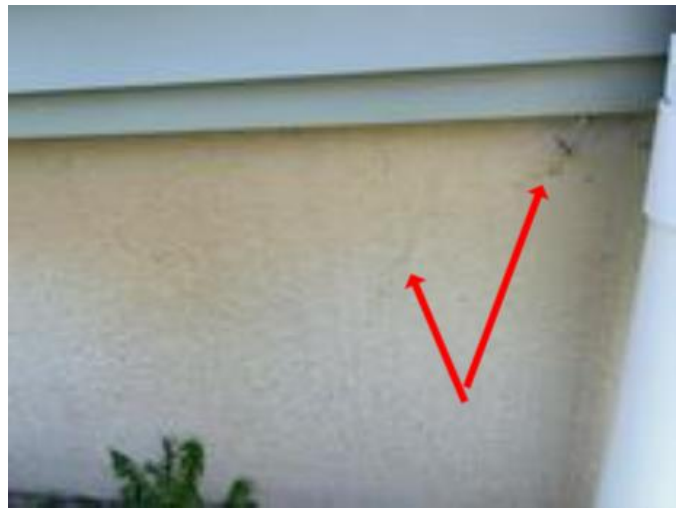
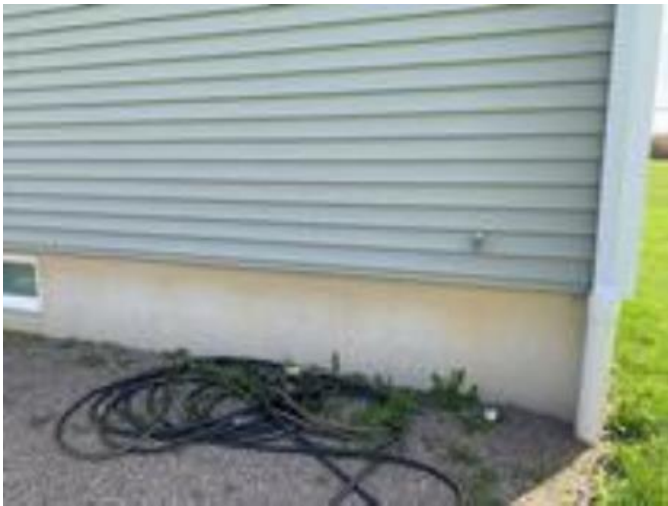
### 4.1 Foundation Conditions (Monitor)

Small minor cracks There are some minor hairline cracks in the foundation. Normally hairline cracks are not the result of foundation failure. These cracks provide an area for water penetration. Monitor and seek the advice of a qualified foundation specialist if necessary.

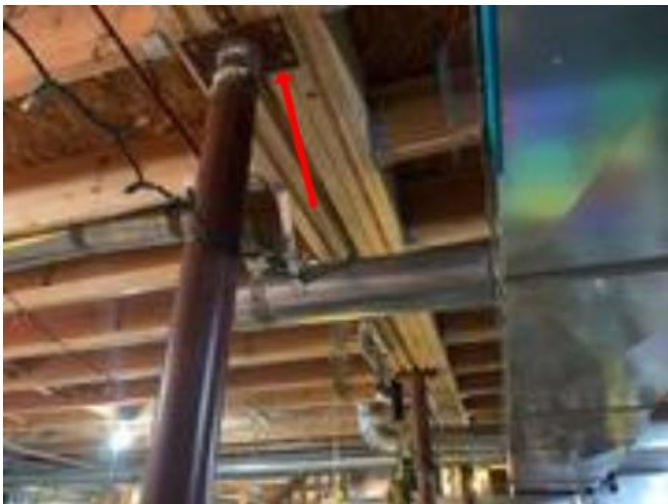
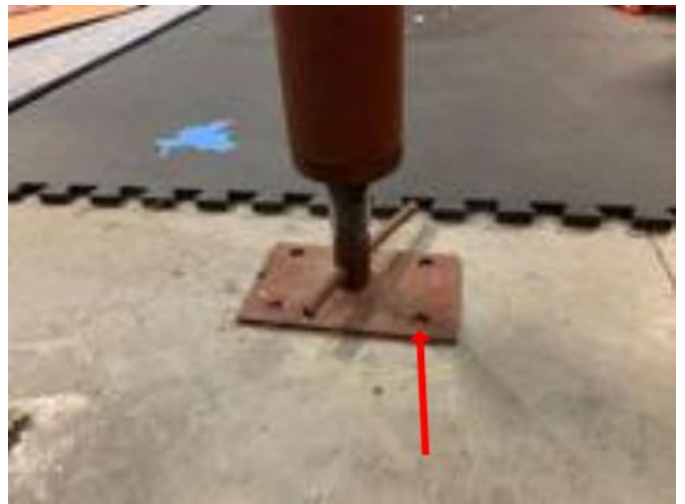
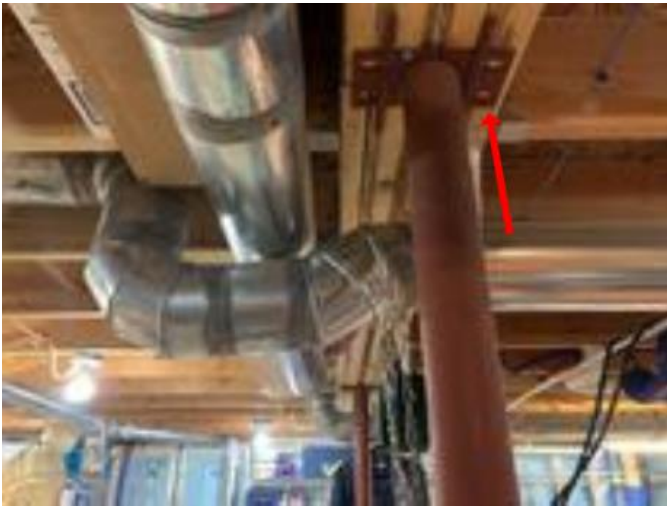
#### 4.2 Flooring Support Conditions (Repair)

The main support posts are not fastened. A basement post exists to support the main beam so it does not sag under the weight of the entire structure. Seek the advice of a qualified contractor for a permanent way of fastening.

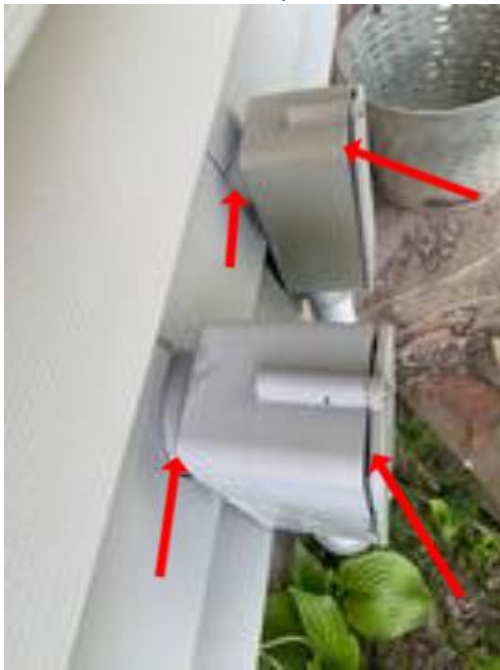
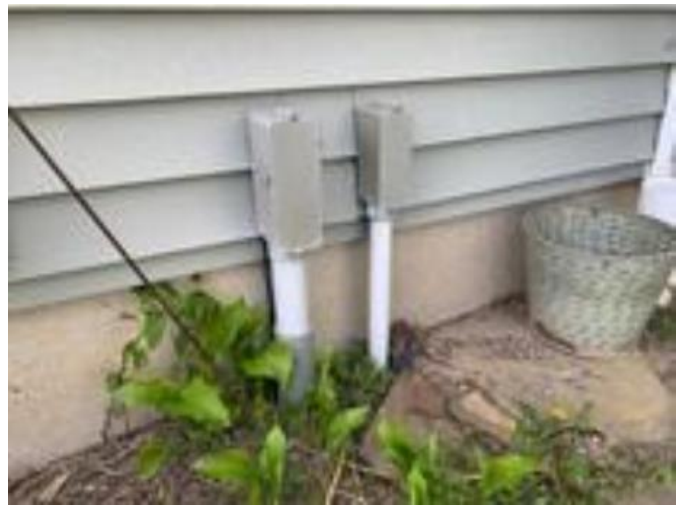
### **6.1 Electrical Service Conditions (Safety)**

The electrical conduit LB fittings have damaged gaskets and no seal at the vinyl siding. In its present condition, water can penetrate and cause a dangerous situation in the electrical service panel. Seek the advice of an electrician to repair as necessary.

Damaged gaskets and no caulking is allowing water to enter.

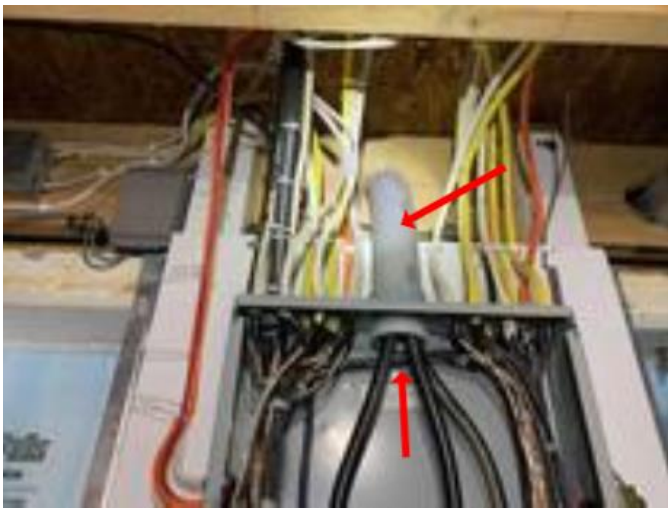
### **6.3 Electrical Panel Conditions (Safety)**

Water is entering the service panel through the conduit goose neck. Evidence is shown as rust on the screws of the bus bar, on the right side of the panel. In the present condition, an unsafe situation is created. I HIGHLY RECOMMEND seeking the advice of a qualified electrician to evaluate and repair.

Water entering from exterior and traveling through goose neck into the service panel.

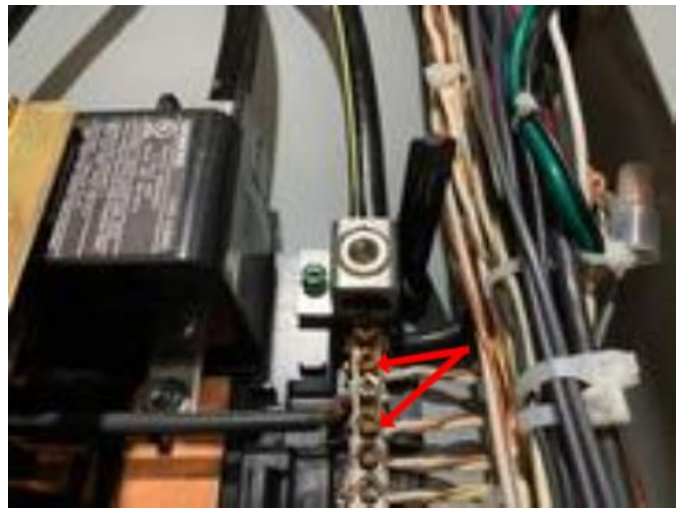
Rust noted.

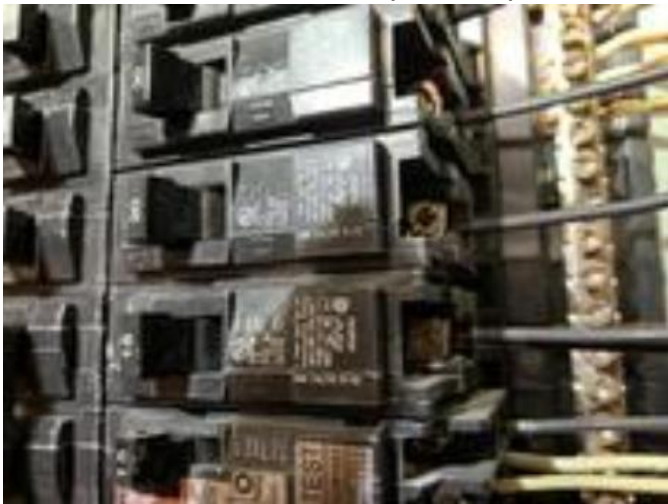
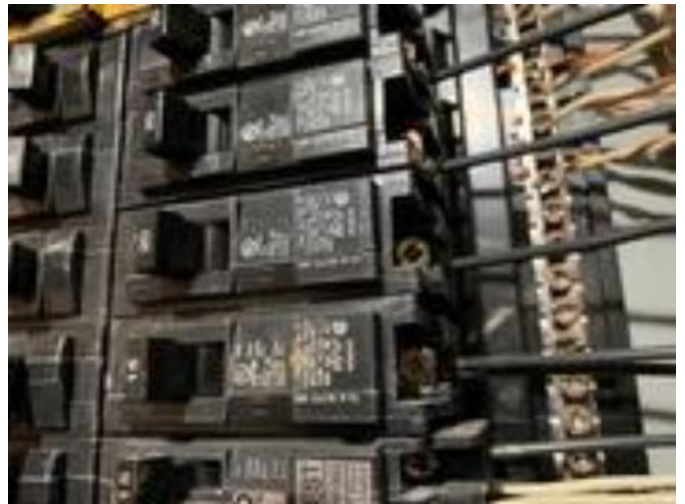
#### **6.4 Electrical Panel Conditions 2 (Safety)**

A 15 amp single pole breaker has two wires attached to it, which is unsafe. A single wire should attach to each breaker terminal. Multiple wires attached to the same terminal can become loose, arc, and create a fire hazard. Seek advice of a qualified professional electrician.

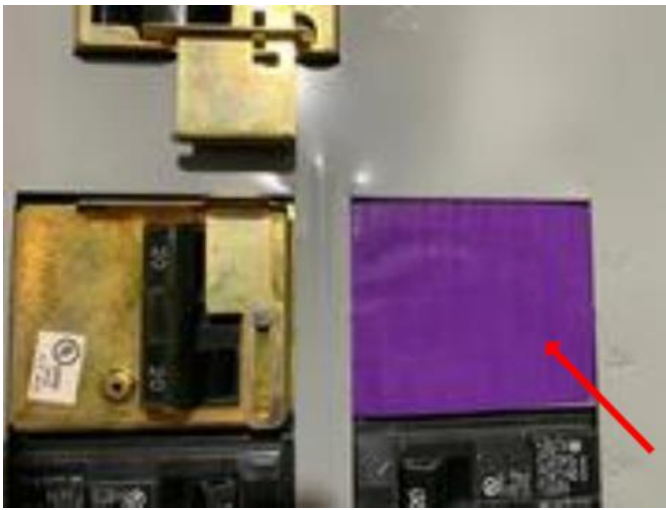
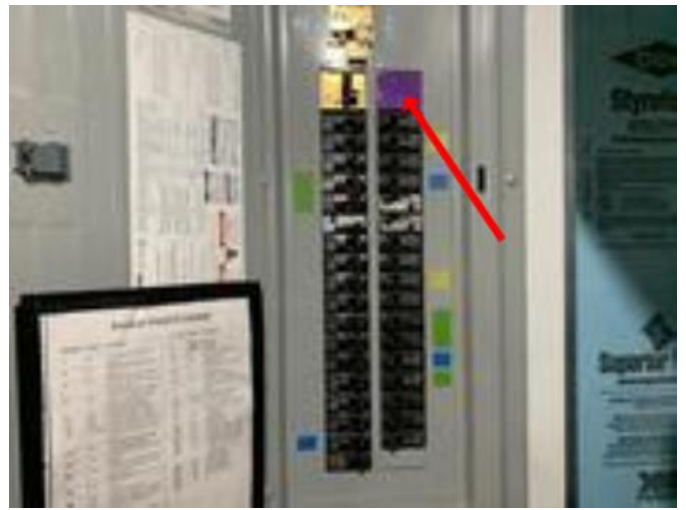
#### **6.5 Electrical Panel Conditions 3 (Safety)**

There are two open slots at the top of the service panel. In its present condition, an unsafe situation exists. A solid, more permanent, cover should be in place. Seek advice from an electrician to repair as necessary.

Note tape

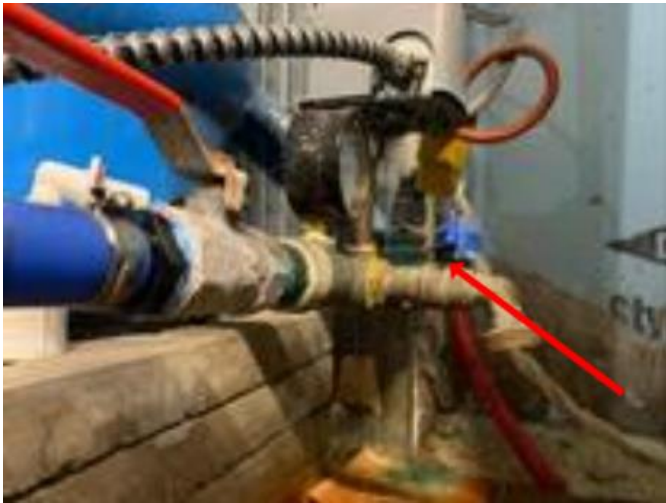
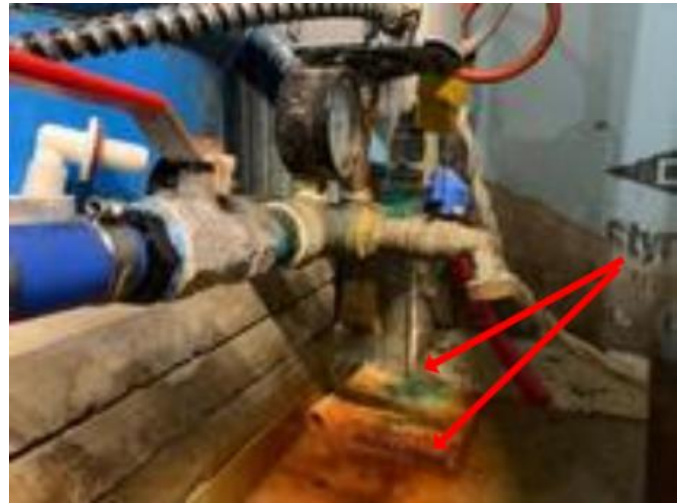
### 7.1 Main Line & Valve Conditions (Repair)

There is a leak under the pressure switch as evidenced by stains on the floor and visible water seen dripping. Seek the advice of a qualified plumbing specialist to repair or replace as necessary.

Note corrosion on floor.

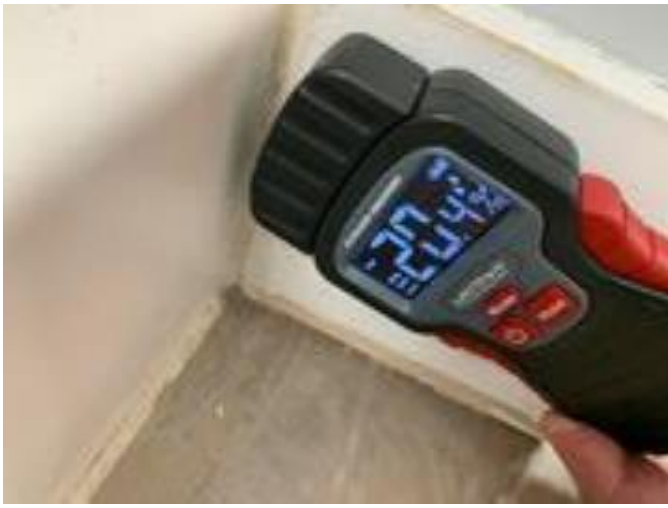
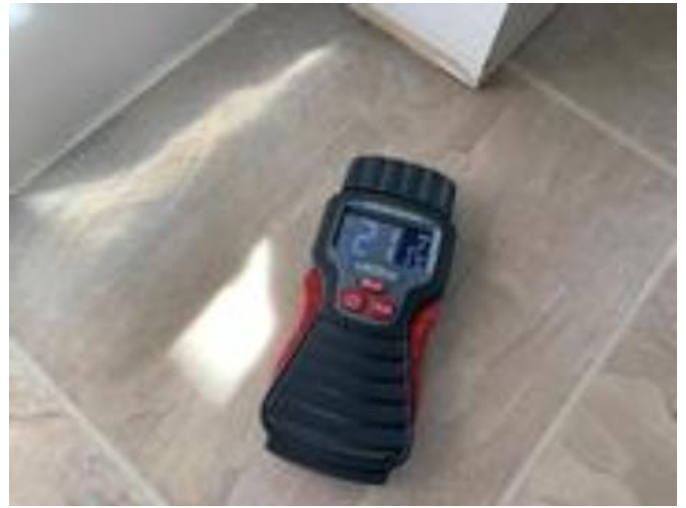
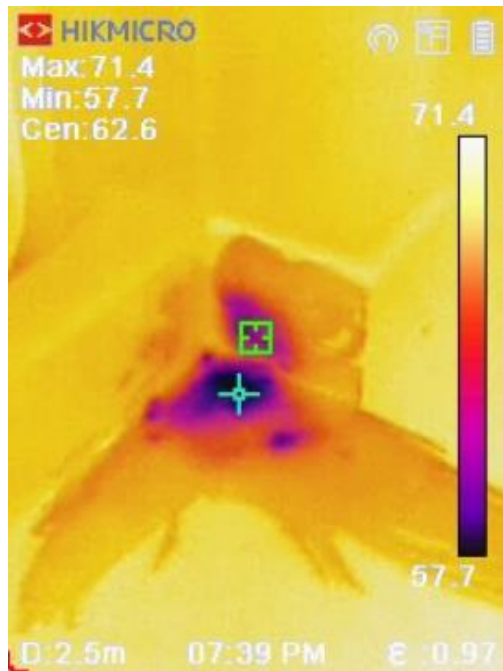
### 9.9 Caulking (Repair)

The master bath shower area has deteriorated and missing caulk. A thermal image was taken and the floor area was tested with a moisture meter and showed excessive moisture. In its present condition, the opportunity is present, over time, for damage. Seek advice to repair as necessary.

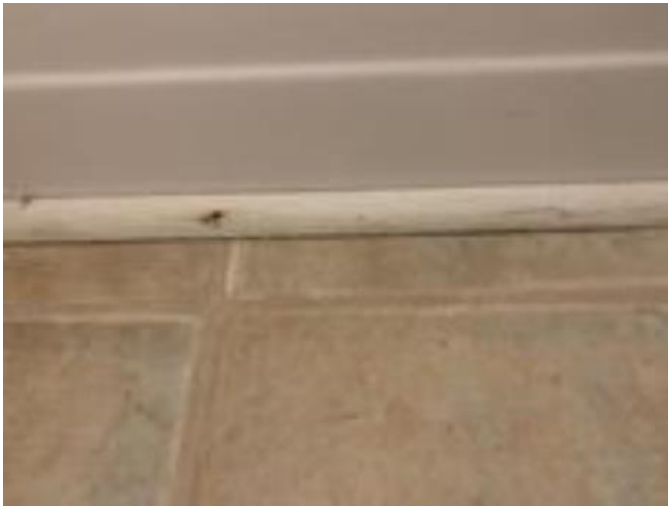
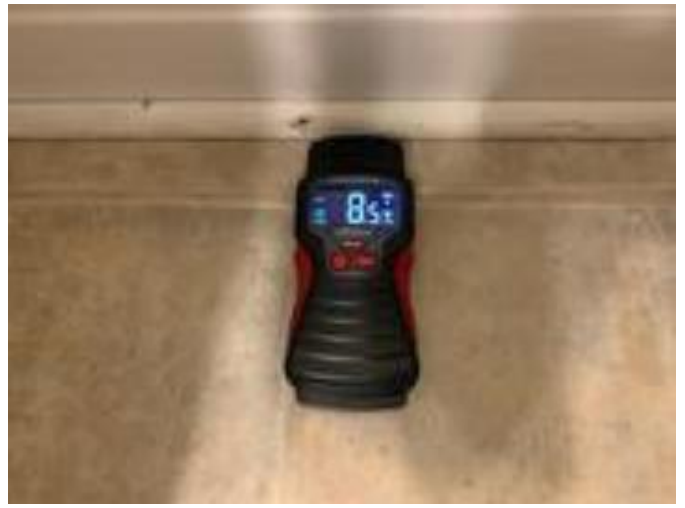
### 10.9 Caulking (Repair)

There is no caulk present at the base of the tub. This area, at the present time, shows no excessive moisture, however, caulking is recommended to prevent the opportunity for moisture damage.

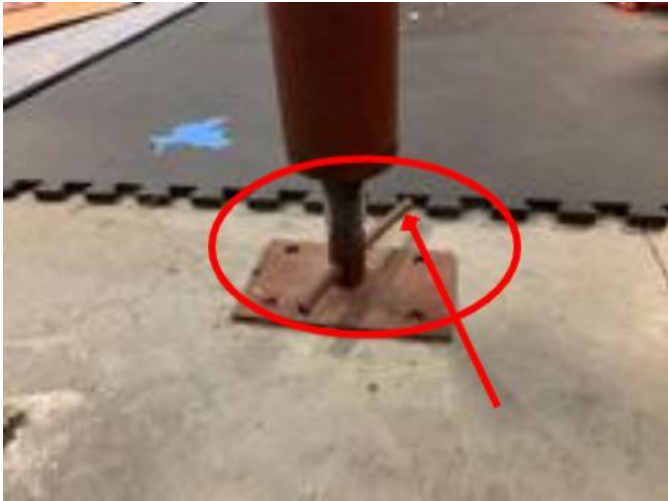
### 13.10 Other Conditions [\(Monitor\)](#)

Adjustable screw jacks were present. Typically, these are used as a temporary installation with no footing support under the screw jack columns. Although we observed no obvious evidence suggesting imminent instability as a result of this condition, permanent steel post or block support with footings under would be proper considering today's standards. Client should consult with a contractor for additional information.
