Inspection Report

CRAFTSMEN
HOME INSPECTION SERVICES, LLC

1234 Comfy Lane Somewhere, New York 14111

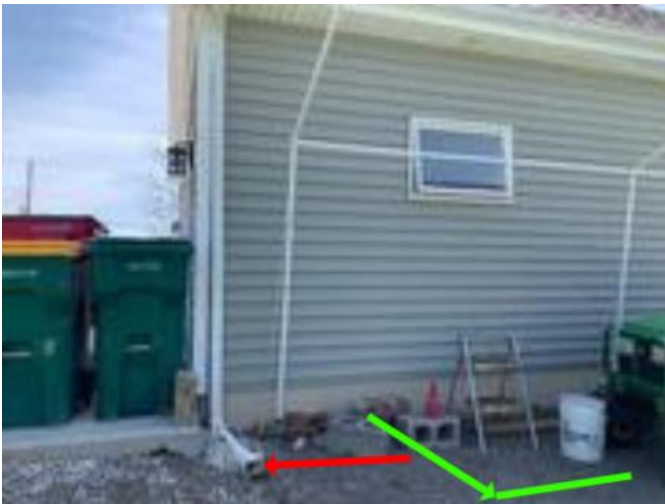
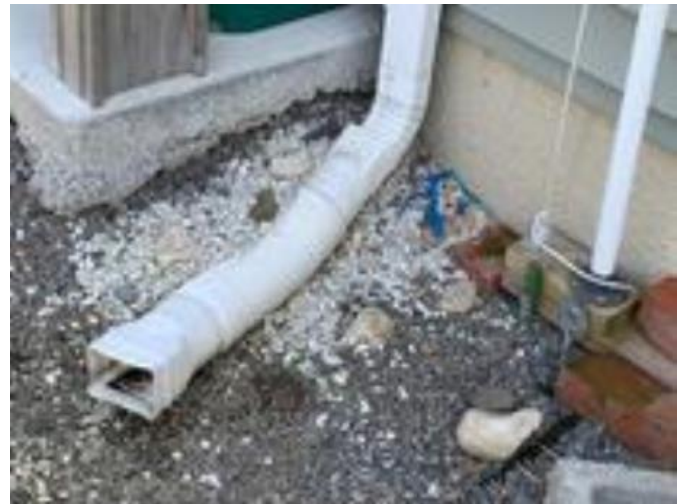
1.3) Gutter & Downspout Conditions

The gutter extension is not long enough. The purpose of the extension is to take water away from the home. In its present condition, water is eroding stone away from under the concrete drive. Seek the advice of a contractor to repair as necessary.

Rainwater should be directed further away from the house.

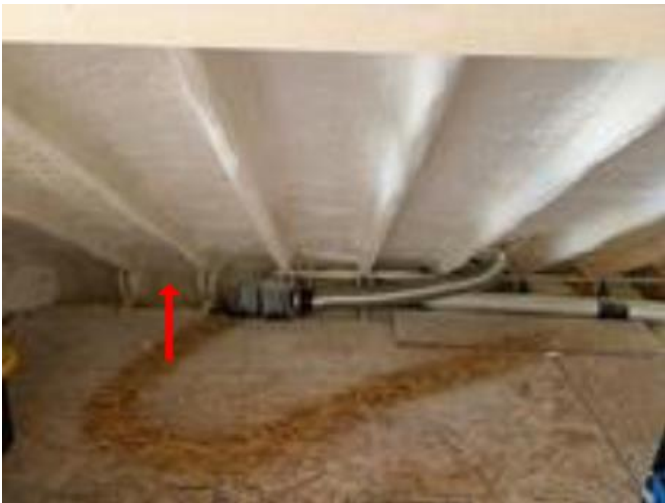
Note the soffit area ventilation is covered.

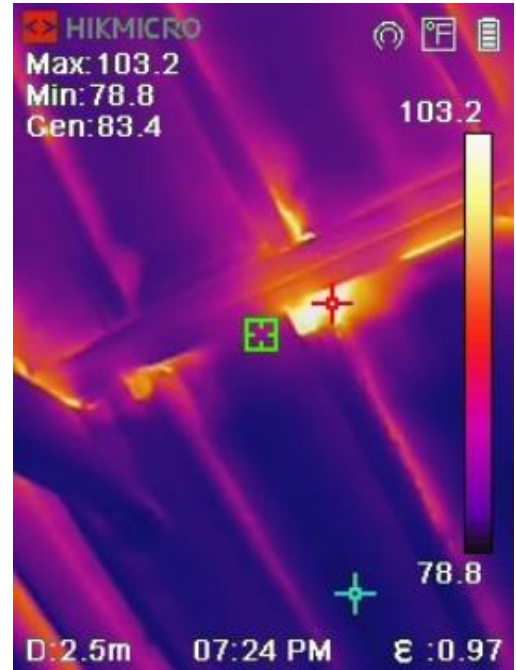
1.7) Attic Insulation Conditions

The spray foam insulation appears to be generally in good condition. There is one area where the insulation appears to be compromised. In its present condition, the insulation in this one area is not functioning as designed.

Note foam material is not attached to the structure.
Exterior heat is able to penetrate into the attic space.

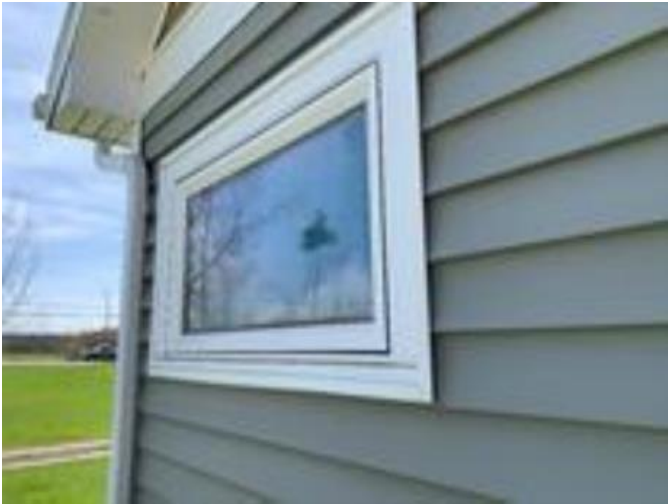
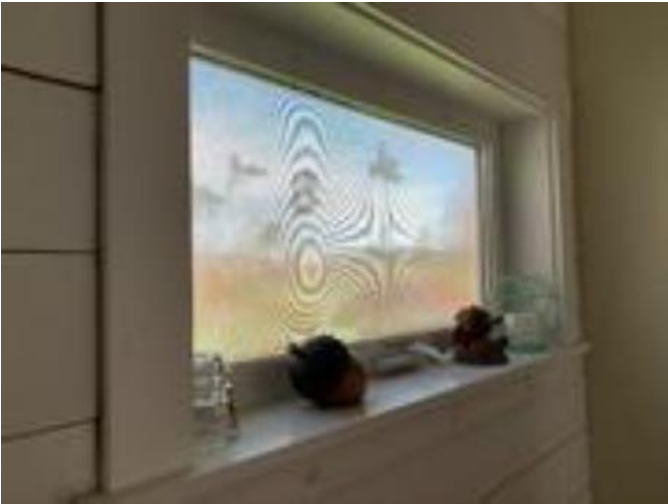
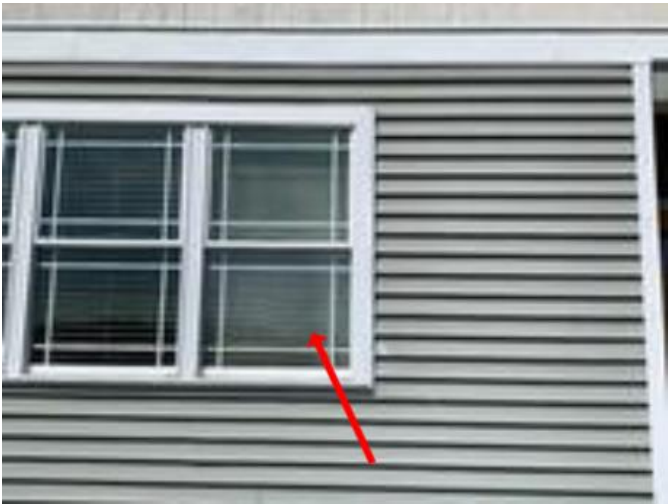
2.4) Window Conditions

The seal is broken on this awning window. In its present condition, the home's energy efficiency is affected. This also affects visibility. The seal is also broken on the front window. In its present condition, the home's energy efficiency is affected. This also affects visibility. Seek advice of a window specialist.

The lower right front window has a broken seal.

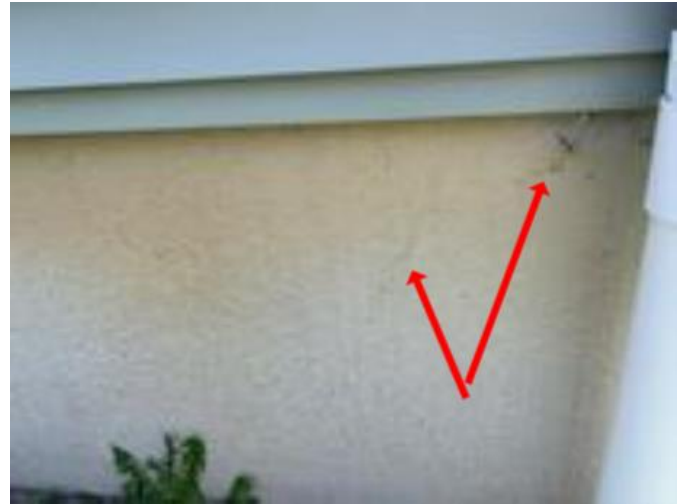
4.1) Foundation Conditions

Small minor cracks There are some minor hairline cracks in the foundation. Normally hairline cracks are not the result of foundation failure. These cracks provide an area for water penetration. Monitor and seek the advice of a qualified foundation specialist if necessary.

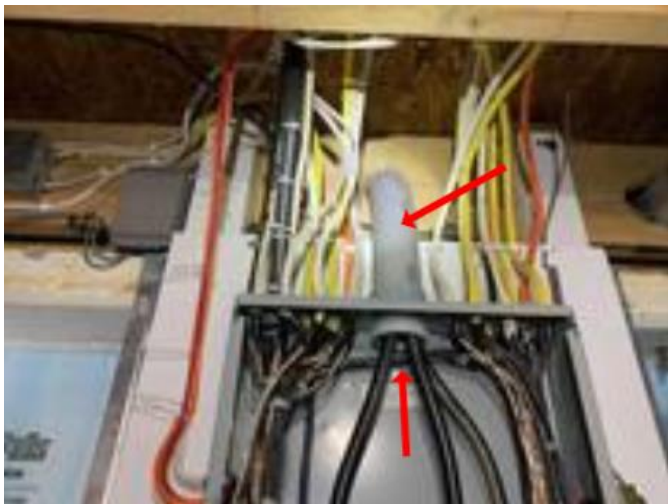
6.3) Electrical Panel Conditions

Water is entering the service panel through the conduit goose neck. Evidence is shown as rust on the screws of the bus bar, on the right side of the panel. In the present condition, an unsafe situation is created. I HIGHLY RECOMMEND seeking the advice of a qualified electrician to evaluate and repair.

Water entering from exterior and traveling through goose neck into the service panel.

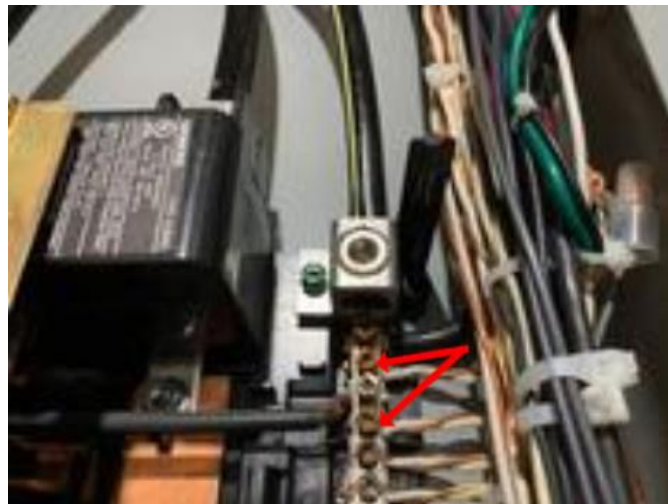
Rust noted.

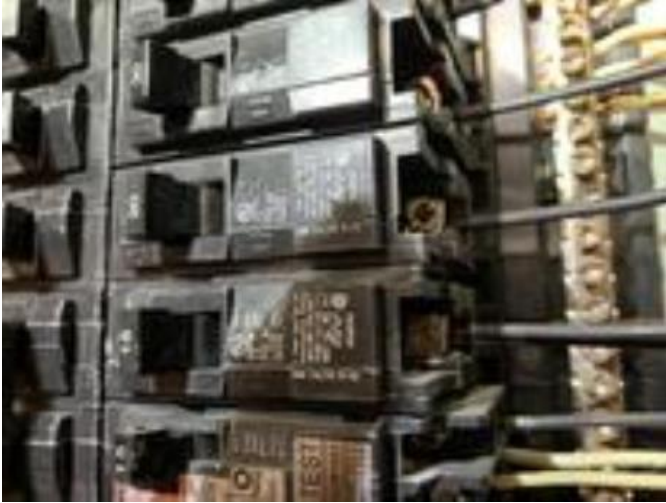
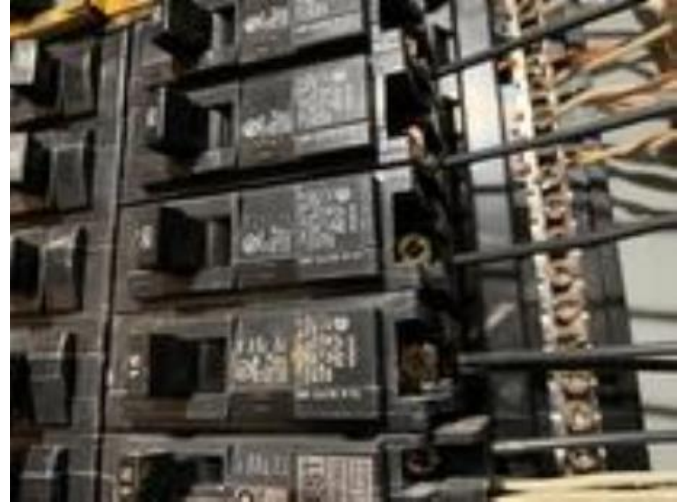
6.4) Electrical Panel Conditions 2

A 15 amp single pole breaker has two wires attached to it, which is unsafe. A single wire should attach to each breaker terminal. Multiple wires attached to the same terminal can become loose, arc, and create a fire hazard. Seek advice of a qualified professional electrician.

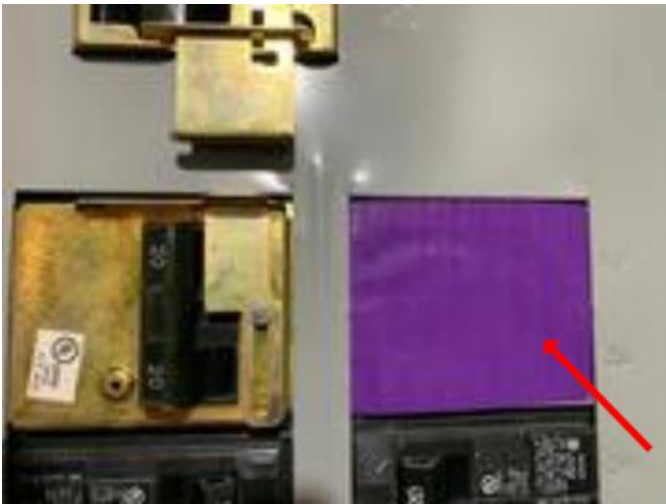
6.5) Electrical Panel Conditions 3

There are two open slots at the top of the service panel. In its present condition, an unsafe situation exists. A solid, more permanent, cover should be in place. Seek advice from an electrician to repair as necessary.

Note tape

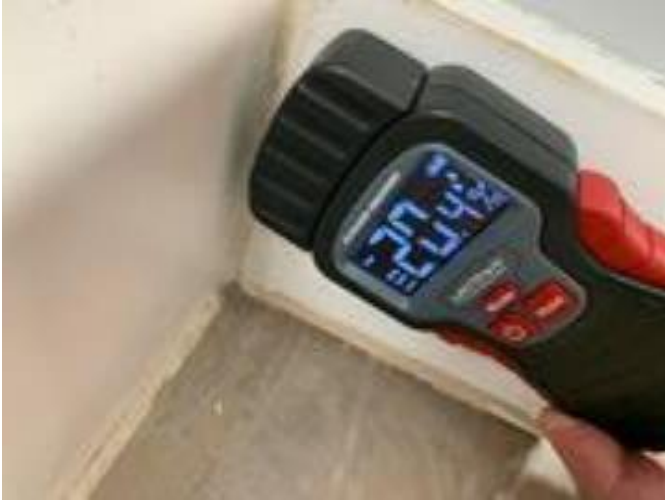
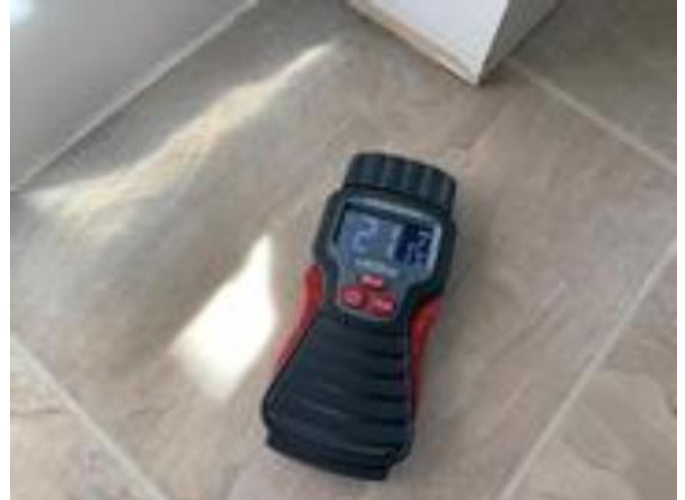
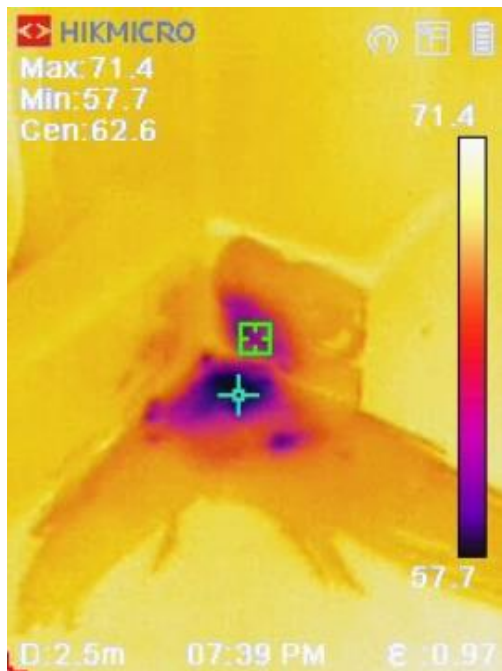
The master bath shower area has deteriorated and missing caulk. A thermal image was taken and the floor area was tested with a moisture meter and showed excessive moisture. In its present condition, the opportunity is present, over time, for damage. Seek advice to repair as necessary.

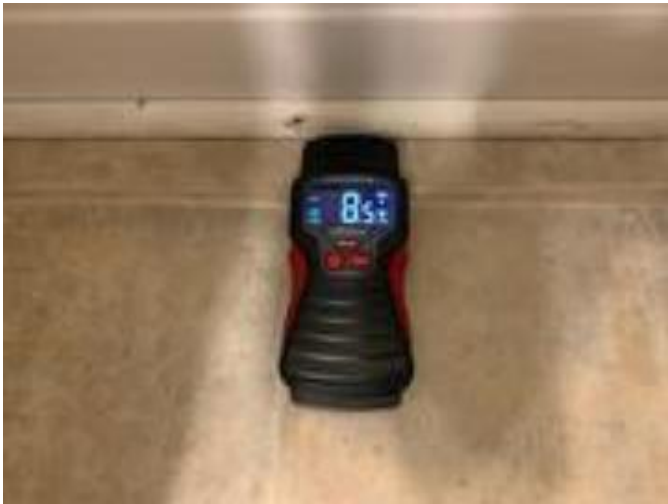
There is no caulk present at the base of the tub. This area, at the present time, shows no excessive moisture, however, caulking is recommended to prevent the opportunity for moisture damage.
