Inspection Report

CRAFTSMEN
HOME INSPECTION SERVICES, LLC

Property Address

1234 Comfy Lane Somewhere, New York 14111

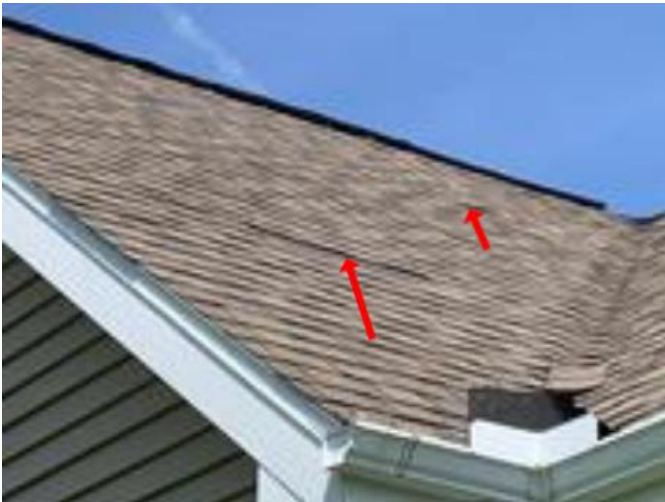
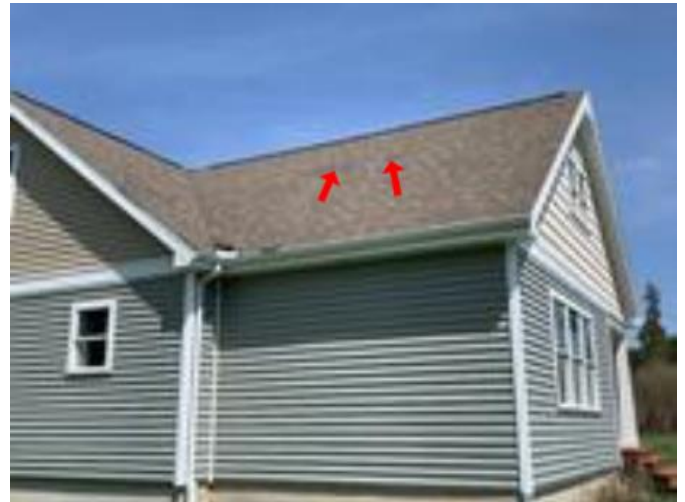
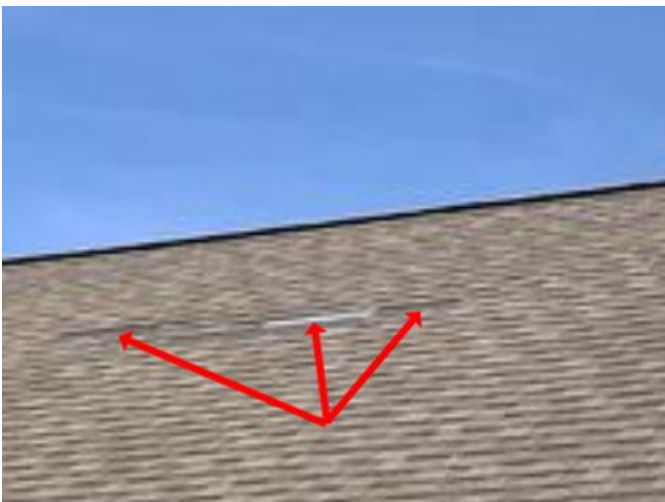
1.1) Roof Covering Condition 1

| Section | Condition# | Comment |
|---|---|---|
| Roof Covering Condition 1 (Repair) | 1.1 | There are areas missing roofing shingles. In its present condition, nails and underlayment are exposed. This allows for water penetration. Seek the advice of a qualified roofing specialist. |

There are areas missing roofing shingles. In its present condition, nails and underlayment are exposed. This allows for water penetration. Seek the advice of a qualified roofing specialist.

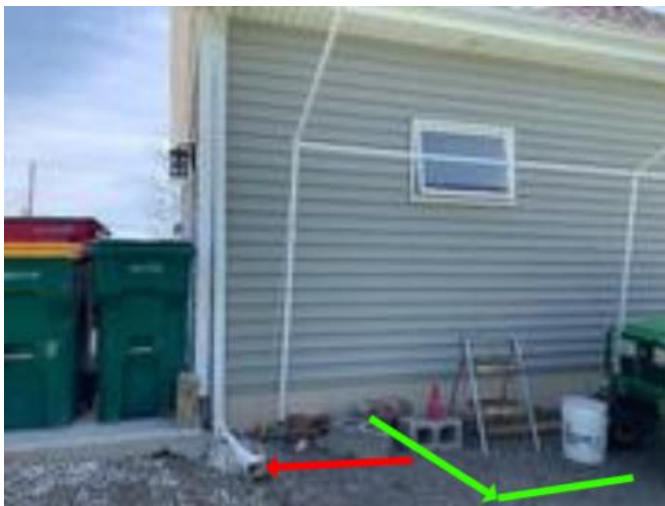
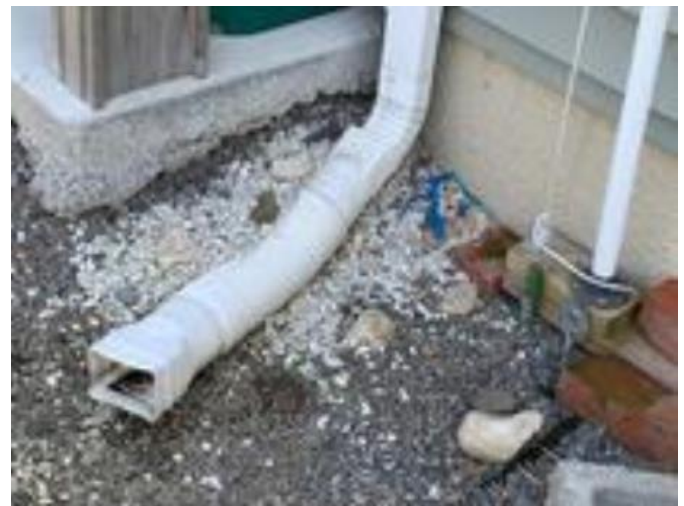
1.3) Gutter & Downspout Conditions

| Section | Condition# | Comment |
|---|---|---|
| Gutter & Downspout Conditions (Repair) | 1.3 | The gutter extension is not long enough. The purpose of the extension is to take water away from the home. In its present condition, water is eroding stone away from under the concrete drive. Seek the advice of a contractor to repair as necessary. |

The gutter extension is not long enough. The purpose of the extension is to take water away from the home. In its present condition, water is eroding stone away from under the concrete drive. Seek the advice of a contractor to repair as necessary.

Rainwater should be directed further away from the house.

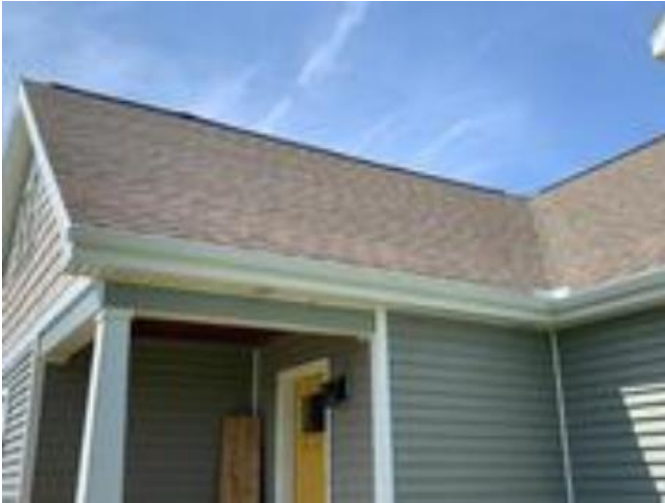
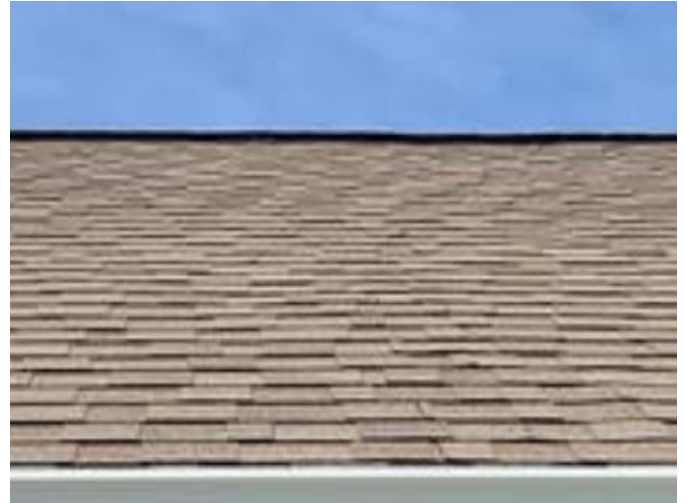
Roof Ventilation

The ridge vent is raised away from the roofing shingles. Its present condition, allows for water penetration and insect intrusion. Spray foam is covering the main roof ridge vent area. In its present condition, the vent is not being used and therefore, is not serving a useful purpose. An unnecessary opening for water penetration exists. Seek the advice of a roofing specialist. advice of a roofing specialist to repair or replace as necessary.

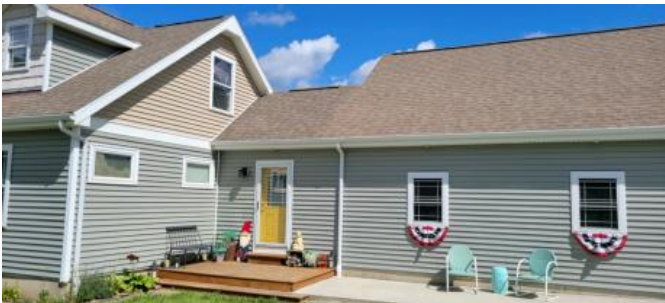
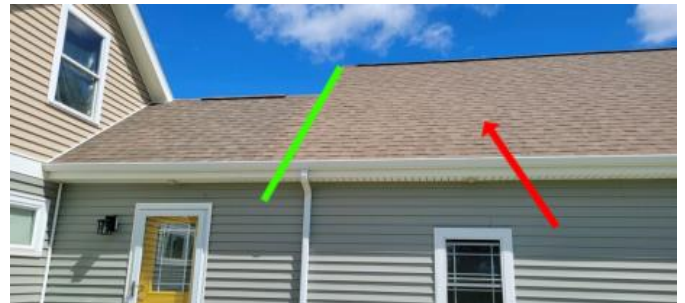
1.4) Roof Covering Conditions 2

The roof shingles on the garage are a different color than the main house. This is only a cosmetic issue and the roof is functioning as designed.

Note lighter brown color on garage roof section.

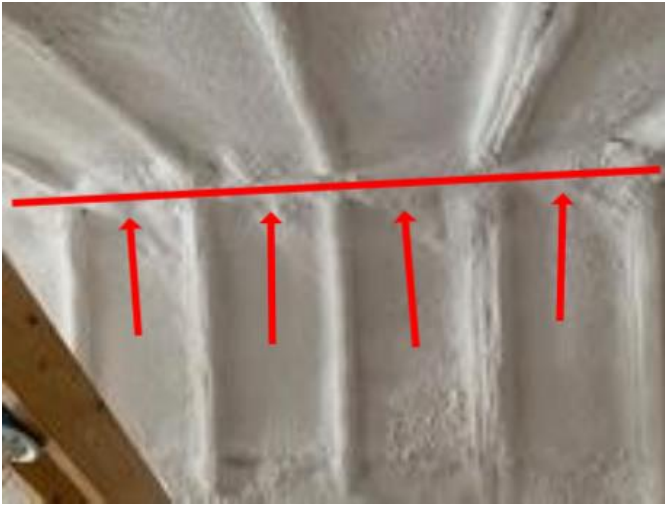
1.6) Attic Ventilation Conditions

| Section | Condition# | Comment |
|---|---|---|
| Attic Ventilation Conditions (Monitor) | 1.6 | The attic area is fully insulated with spray foam. The ridge and soffit vents are blocked. In its present condition, the air is not circulating and feels heavy. Seek the advice of an indoor air quality specialist to evaluate. |

The attic area is fully insulated with spray foam. The ridge and soffit vents are blocked. In its present condition, the air is not circulating and feels heavy. Seek the advice of an indoor air quality specialist to evaluate.

Note the ridge vent area is covered.

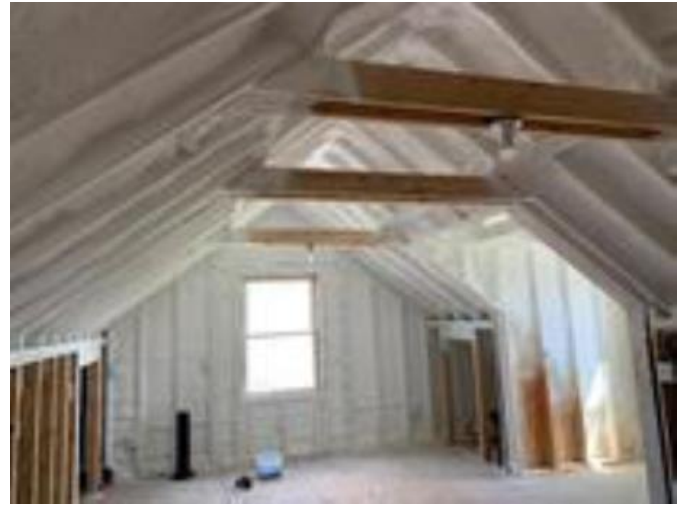
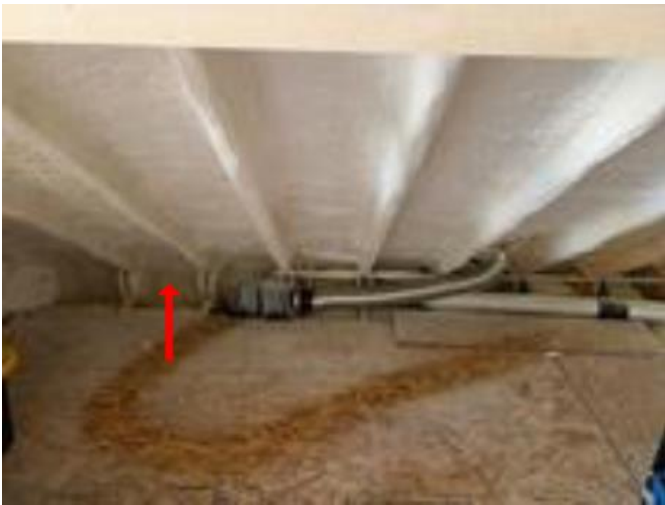
Note the soffit area ventilation is covered.

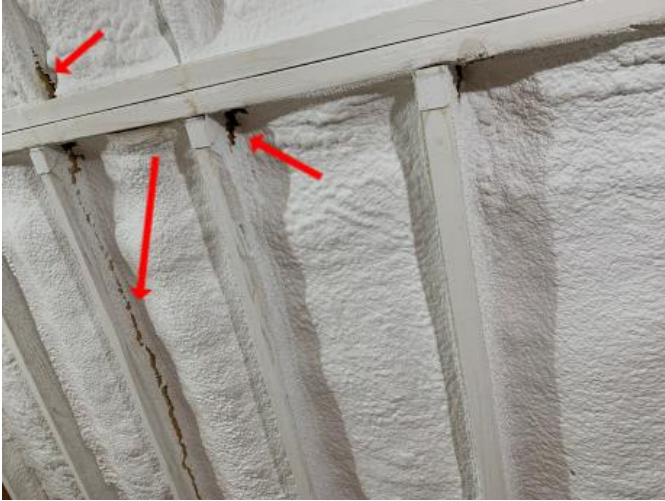
1.7) Attic Insulation Conditions

| Section | Condition# | Comment |
|---|---|---|
| Attic Insulation Conditions (Monitor) | 1.7 | The spray foam insulation appears to be generally in good condition. There is one area where the insulation appears to be compromised. In its present condition, the insulation in this one area is not functioning as designed. |

The spray foam insulation appears to be generally in good condition. There is one area where the insulation appears to be compromised. In its present condition, the insulation in this one area is not functioning as designed.

Note foam material is not attached to the structure.
Exterior heat is able to penetrate into the attic space.

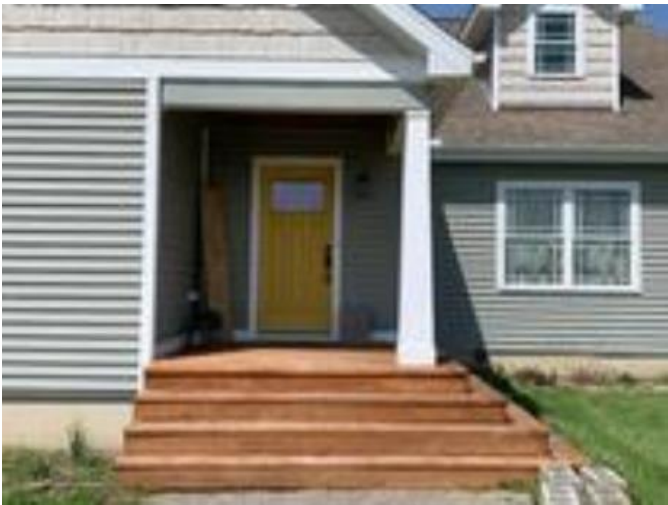
2.1) Front Entrance Conditions S

| Section | Condition# | Comment |
|---|---|---|
| Front Entrance Conditions (Safety) | 2.1 | There are no railings on the front porch. In its present condition, an unsafe situation is present. Seek advice of a contractor to evaluate. Also, both front porch areas have stain in need of attention. In its present condition, bare wood is exposed to the elements, and the structural integrity of the wood is compromised. Consider applying a fresh coat of stain or consult a painting specialist. |

There are no railings on the front porch. In its present condition, an unsafe situation is present. Seek advice of a contractor to evaluate. Also, both front porch areas have stain in need of attention. In its present condition, bare wood is exposed to the elements, and the structural integrity of the wood is compromised. Consider applying a fresh coat of stain or consult a painting specialist.

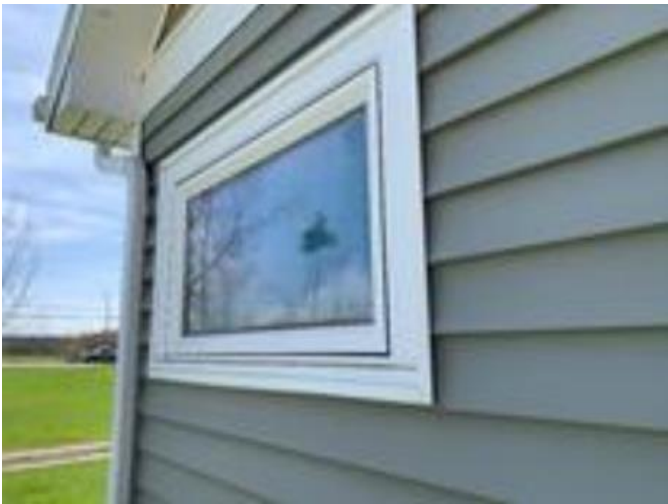
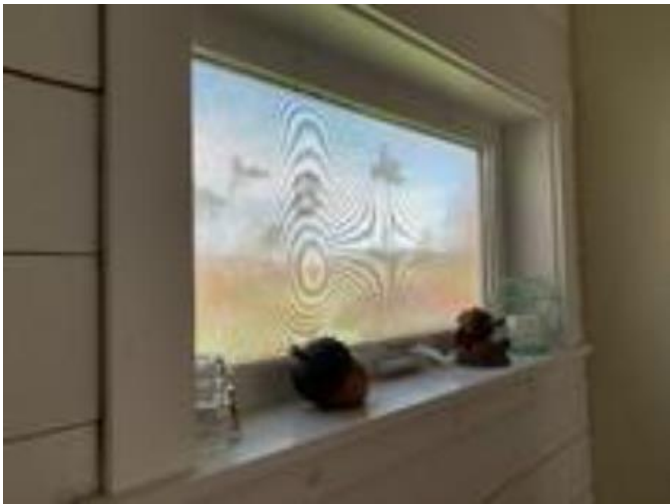
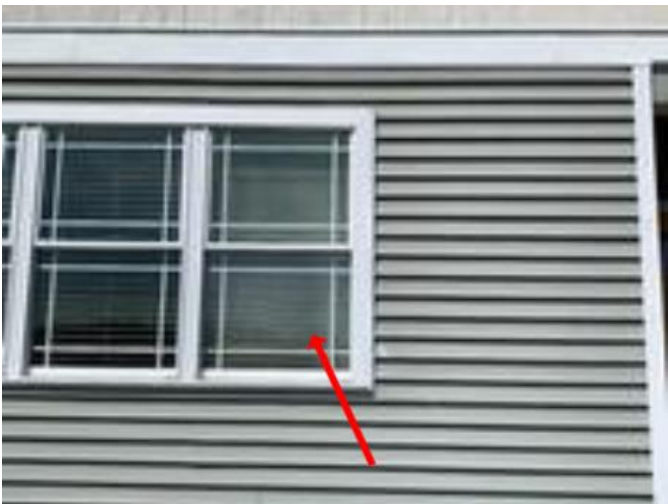
2.4) Window Conditions

| Section | Condition# | Comment |
|---|---|---|
| Window Conditions (Repair) | 2.4 | The seal is broken on this awning window. In its present condition, the home's energy efficiency is affected. This also affects visibility. The seal is also broken on the front window. In its present condition, the home's energy efficiency is affected. This also affects visibility. Seek advice of a window specialist. |

The seal is broken on this awning window. In its present condition, the home's energy efficiency is affected. This also affects visibility. The seal is also broken on the front window. In its present condition, the home's energy efficiency is affected. This also affects visibility. Seek advice of a window specialist.

The lower right front window has a broken seal.

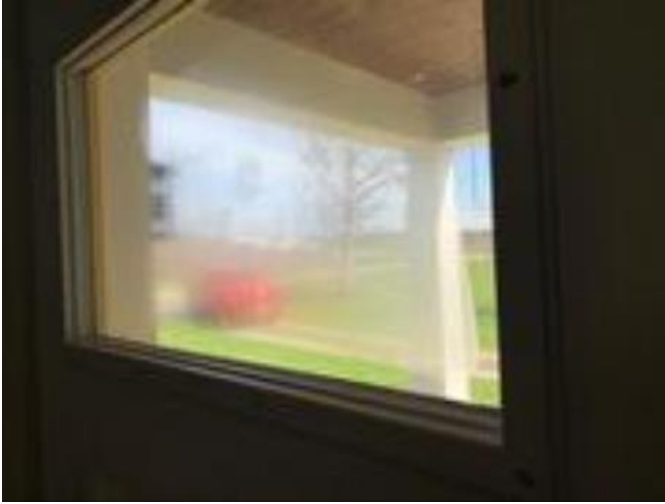
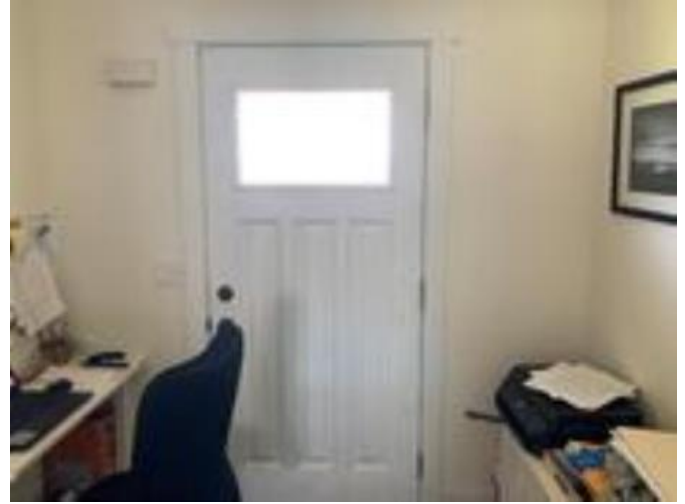
2.5) Exterior Door Conditions

| Section | Condition# | Comment |
|---|---|---|
| Exterior Door Conditions (Repair) | 2.5 | The seal is broken on the main entry door window. In its present condition, the home's energy efficiency is affected. This also affects visibility. Seek advice of a window and door specialist. |

The seal is broken on the main entry door window. In its present condition, the home's energy efficiency is affected. This also affects visibility. Seek advice of a window and door specialist.

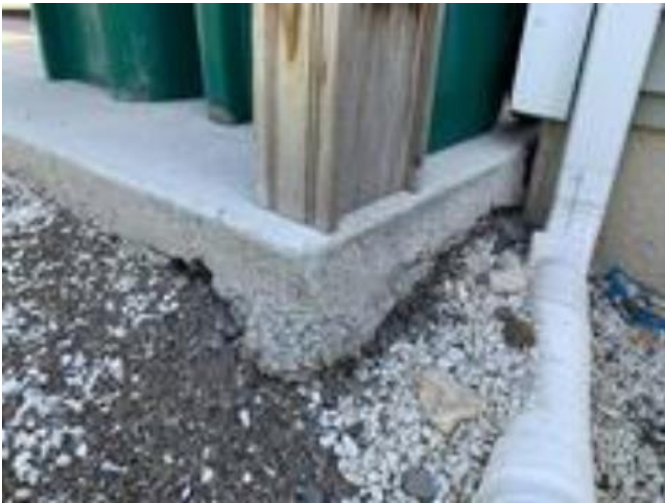
3.2) Driveway Conditions

| Section | Condition# | Comment |
|---|---|---|
| Driveway Conditions (Monitor) | 3.2 | The stone base of the driveway is eroding out from under the concrete. In its present condition, the integrity of the driveway is being compromised. Seek advice of a qualified landscaper to repair as necessary. |

The stone base of the driveway is eroding out from under the concrete. In its present condition, the integrity of the driveway is being compromised. Seek advice of a qualified landscaper to repair as necessary.

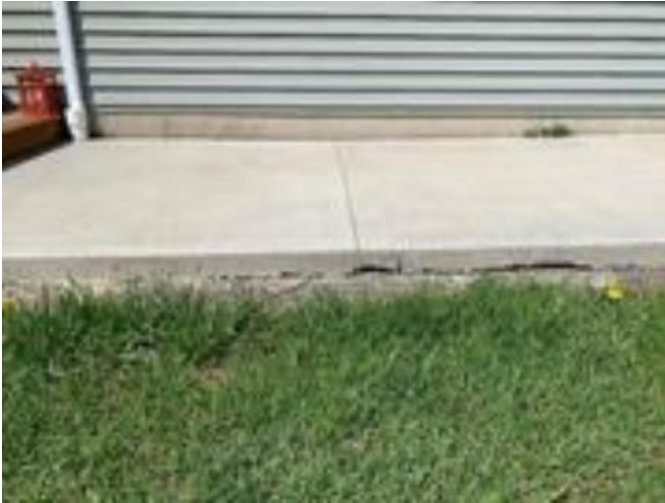
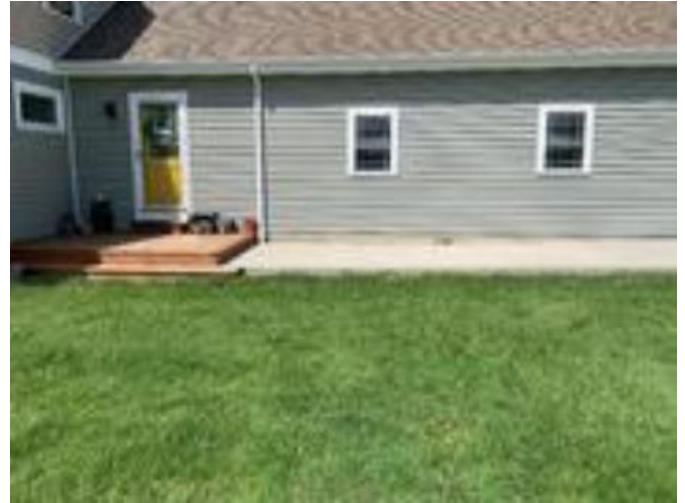
3.3) Sidewalk Conditions

| Sidewalk Conditions (Monitor) | 3.3 | The concrete walkway is tilted toward the house. This allows for water to drain toward the foundation of the home. Monitor the basement area for water penetration. Seek the advice of a foundation specialist if necessary. |

The concrete walkway is tilted toward the house. This allows for water to drain toward the foundation of the home. Monitor the basement area for water penetration. Seek the advice of a foundation specialist if necessary.

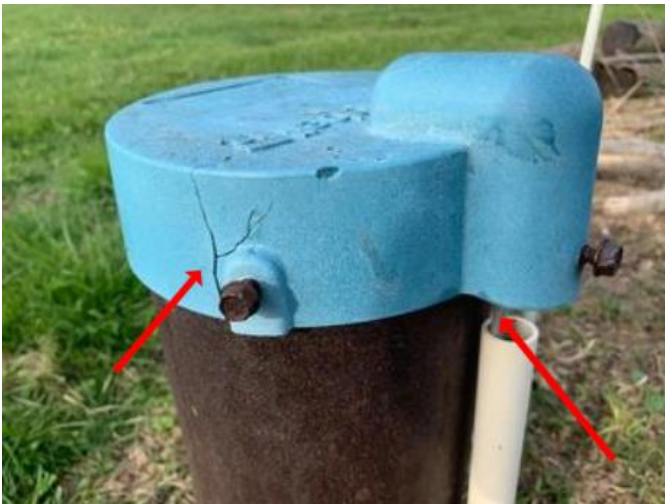
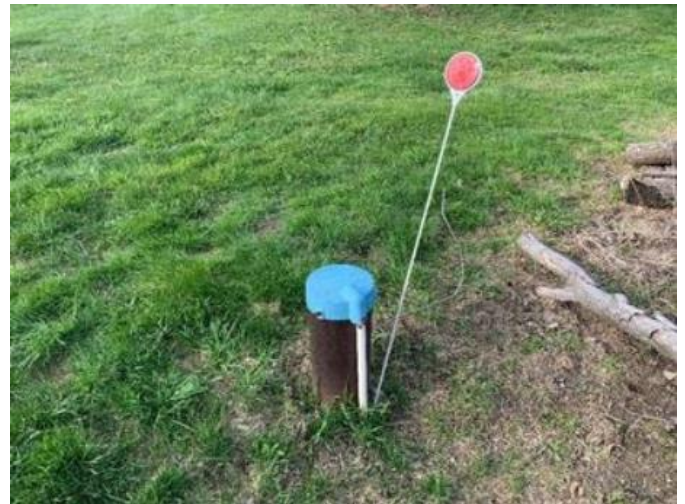
3.4) Well Head Conditions

| Well Head Conditions (Repair) | 3.4 | The well head cap is cracked and is a standard cap. You may wish to replace it with a sanitary cap. In its present condition, dirt, insects, and bacteria, is able to penetrate the casing cavity. Seek the advice of a well specialist to evaluate and replace as necessary. The wire sending power is exposed. The plastic conduit is pulled away from the cap. In its present condition, it may become damaged. |

The well head cap is cracked and is a standard cap. You may wish to replace it with a sanitary cap. In its present condition, dirt, insects, and bacteria, is able to penetrate the casing cavity. Seek the advice of a well specialist to evaluate and replace as necessary. The wire sending power is exposed. The plastic conduit is pulled away from the cap. In its present condition, it may become damaged.

Crack noted on the well cap. Plastic conduit separated from the cap, exposing wire.

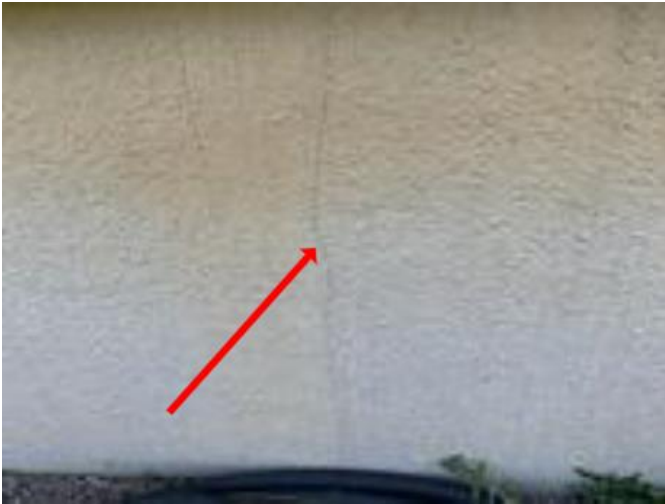
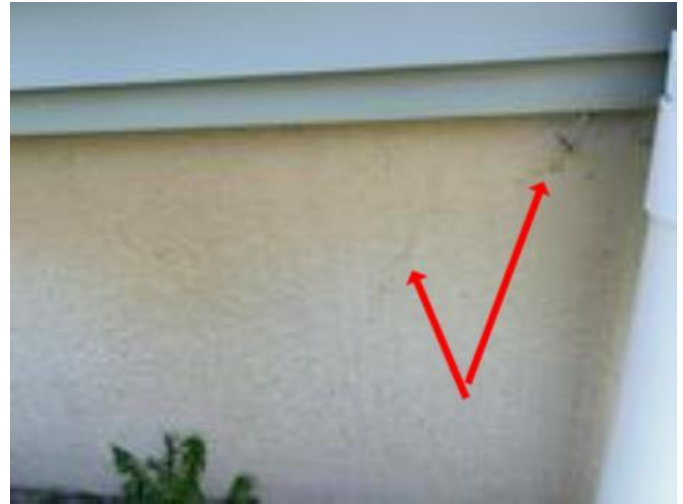
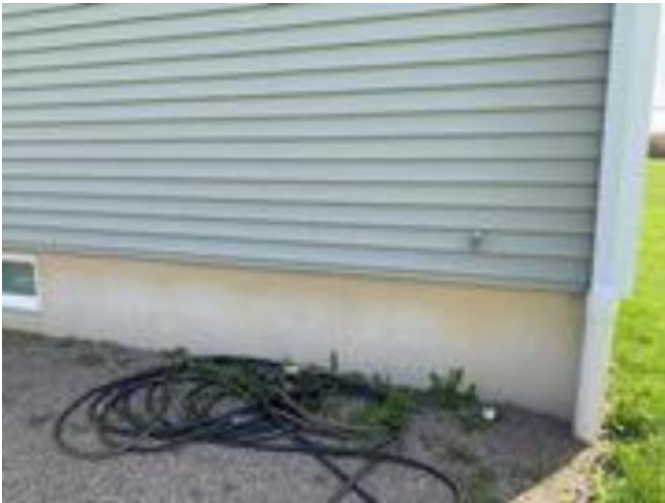
4.1) Foundation Conditions

| Foundation Conditions (Monitor) | 4.1 | Small minor cracks There are some minor hairline cracks in the foundation. Normally hairline cracks are not the result of foundation failure. These cracks provide an area for water penetration. Monitor and seek the advice of a qualified foundation specialist if necessary. |

Small minor cracks There are some minor hairline cracks in the foundation. Normally hairline cracks are not the result of foundation failure. These cracks provide an area for water penetration. Monitor and seek the advice of a qualified foundation specialist if necessary.

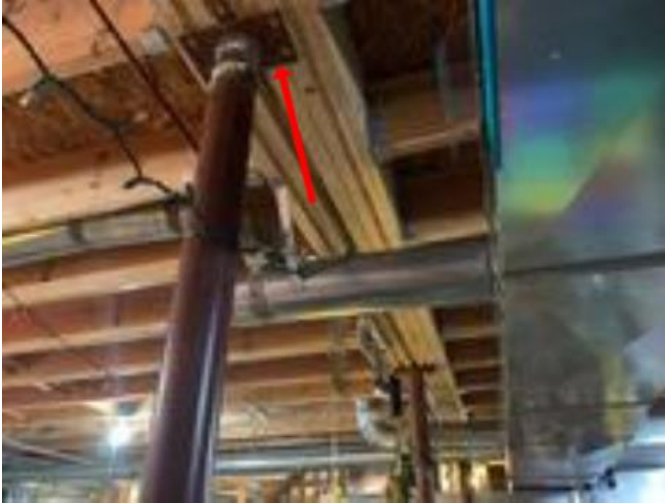
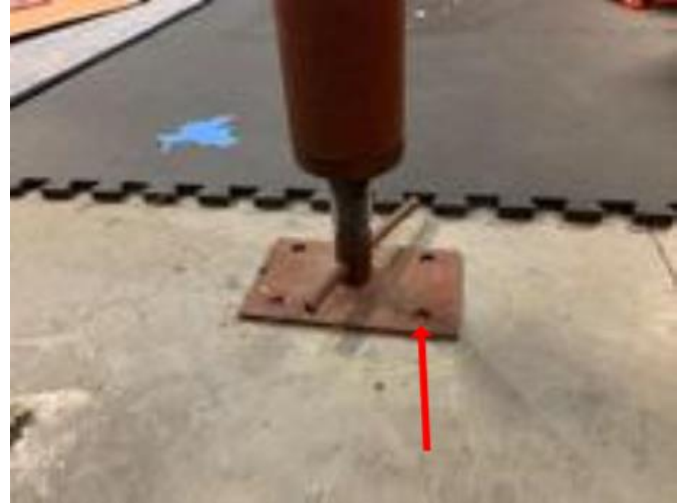
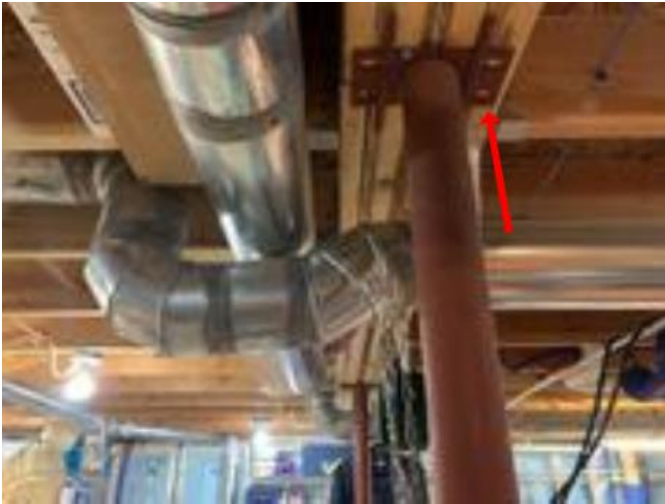
4.2) Flooring Support Conditions

| Flooring Support Conditions (Repair) | 4.2 | The main support posts are not fastened. A basement post exists to support the main beam so it does not sag under the weight of the entire structure. Seek the advice of a qualified contractor for a permanent way of fastening. |

The main support posts are not fastened. A basement post exists to support the main beam so it does not sag under the weight of the entire structure. Seek the advice of a qualified contractor for a permanent way of fastening.

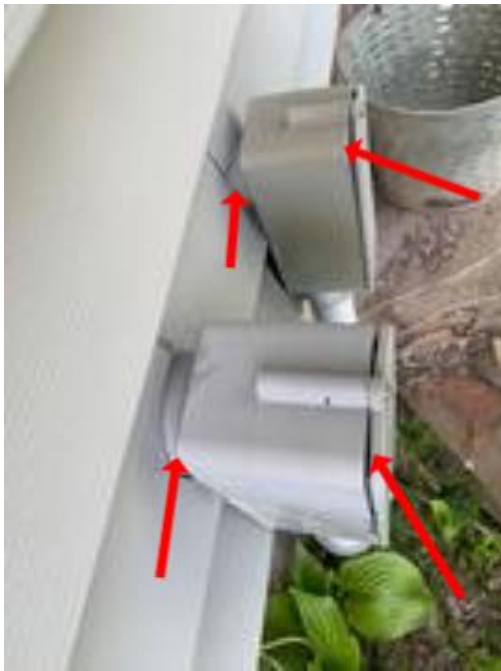
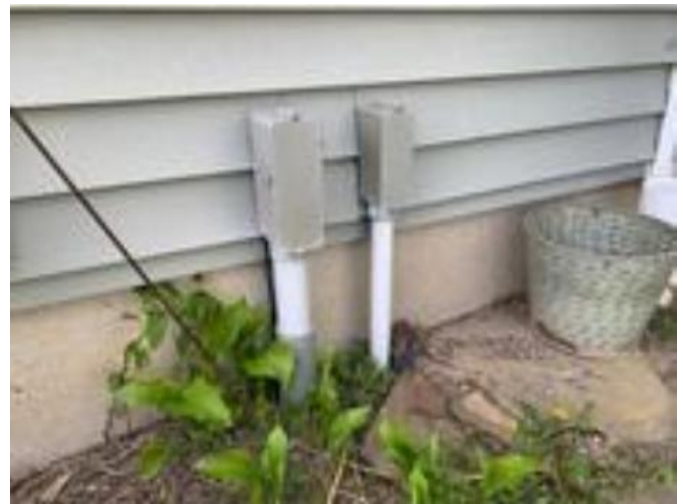
| 6.1) Electrical Service Conditions | <div>S</div> |

| Electrical Service Conditions (Safety) | 6.1 | The electrical conduit LB fittings have damaged gaskets and no seal at the vinyl siding. In its present condition, water can penetrate and cause a dangerous situation in the electrical service panel. Seek the advice of an electrician to repair as necessary. |

The electrical conduit LB fittings have damaged gaskets and no seal at the vinyl siding. In its present condition, water can penetrate and cause a dangerous situation in the electrical service panel. Seek the advice of an electrician to repair as necessary.

Damaged gaskets and no caulking is allowing water to enter.

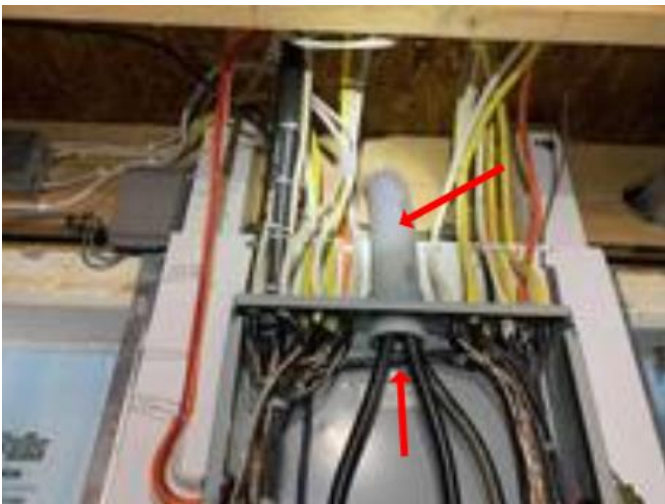
6.3) Electrical Panel Conditions

| Electrical Panel Conditions (Safety) | 6.3 | Water is entering the service panel through the conduit goose neck. Evidence is shown as rust on the screws of the bus bar, on the right side of the panel. In the present condition, an unsafe situation is created. I HIGHLY RECOMMEND seeking the advice of a qualified electrician to evaluate and repair. |

Water is entering the service panel through the conduit goose neck. Evidence is shown as rust on the screws of the bus bar, on the right side of the panel. In the present condition, an unsafe situation is created. I HIGHLY RECOMMEND seeking the advice of a qualified electrician to evaluate and repair.

Water entering from exterior and traveling through goose neck into the service panel.

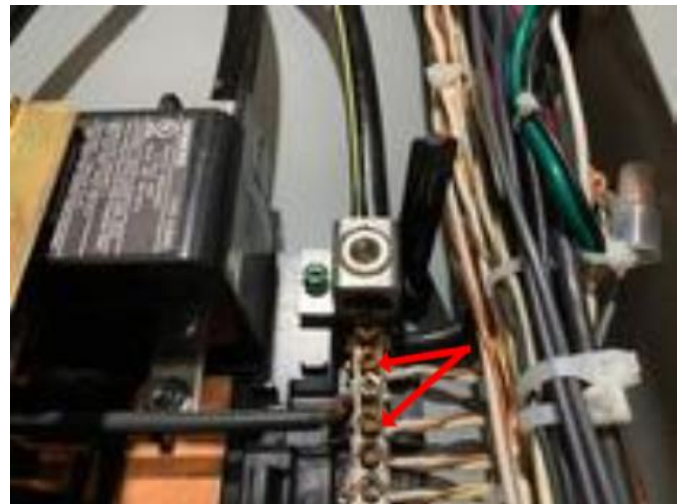
Rust noted.

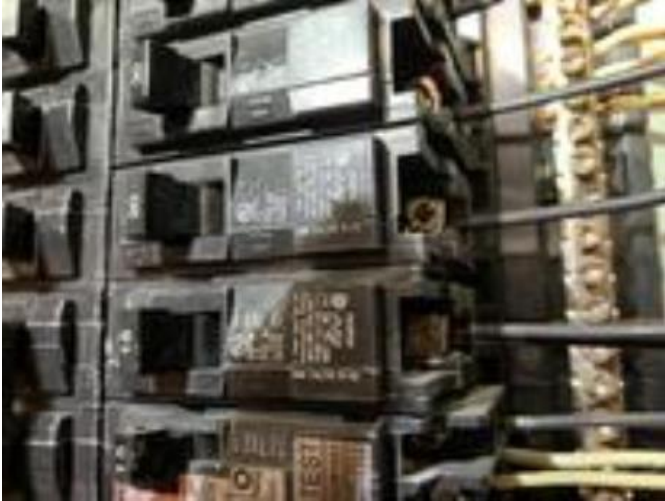
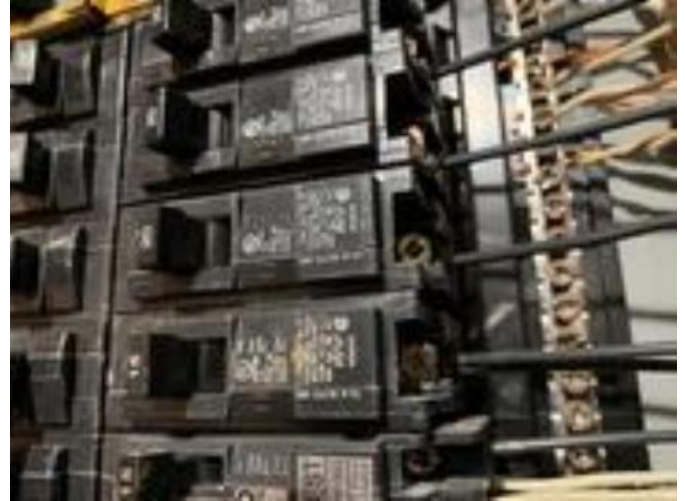
6.4) Electrical Panel Conditions 2

| Electrical Panel Conditions 2 (Safety) | 6.4 | A 15 amp single pole breaker has two wires attached to it, which is unsafe. A single wire should attach to each breaker terminal. Multiple wires attached to the same terminal can become loose, arc, and create a fire hazard. Seek advice of a qualified professional electrician. |

A 15 amp single pole breaker has two wires attached to it, which is unsafe. A single wire should attach to each breaker terminal. Multiple wires attached to the same terminal can become loose, arc, and create a fire hazard. Seek advice of a qualified professional electrician.

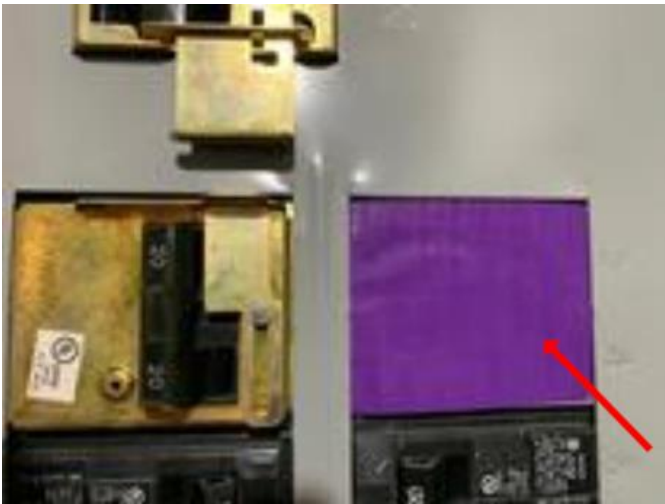
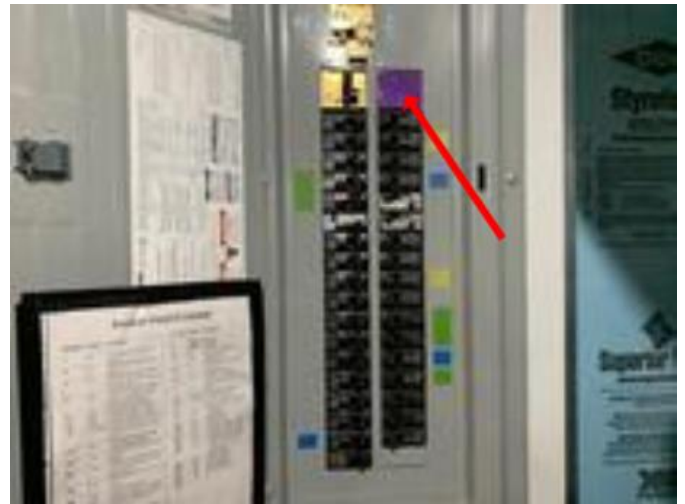
6.5) Electrical Panel Conditions 3

| Electrical Panel Conditions 3 (Safety) | 6.5 | There are two open slots at the top of the service panel. In its present condition, an unsafe situation exists. A solid, more permanent, cover should be in place. Seek advice from an electrician to repair as necessary. |

There are two open slots at the top of the service panel. In its present condition, an unsafe situation exists. A solid, more permanent, cover should be in place. Seek advice from an electrician to repair as necessary.

Note tape

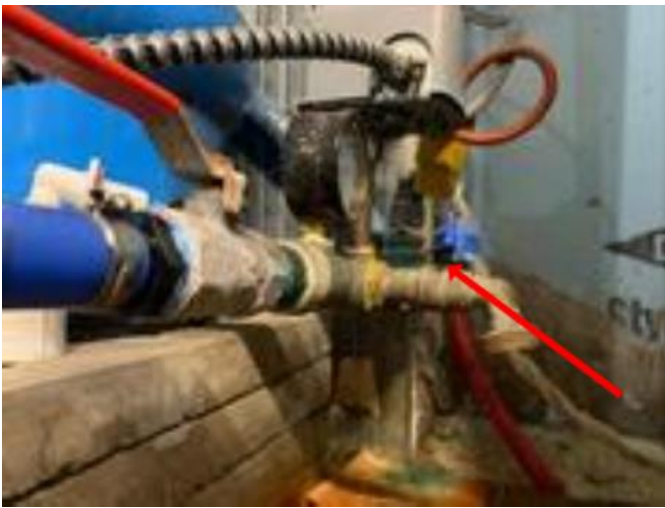
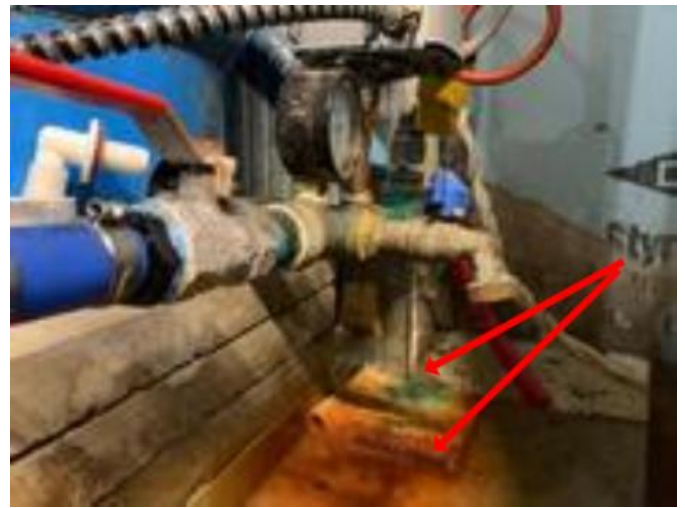
7.1) Main Line & Valve Conditions

| Main Line & Valve Conditions (Repair) | 7.1 | There is a leak under the pressure switch as evidenced by stains on the floor and visible water seen dripping. Seek the advice of a qualified plumbing specialist to repair or replace as necessary. |

There is a leak under the pressure switch as evidenced by stains on the floor and visible water seen dripping. Seek the advice of a qualified plumbing specialist to repair or replace as necessary.

Note corrosion on floor.

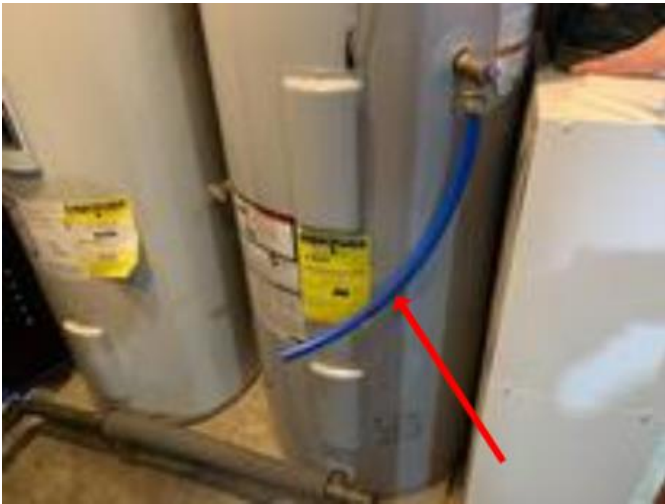
7.4) Water Heater Condition 1**S**

The safety relief valve extension pipe is not long enough. In its present condition, if the pressure relief valve were needed, it would not allow the hot water to safely discharge to the floor. Seek the advice of a plumber to repair as necessary.

Note blue pipe not directing hot water safely to the ground

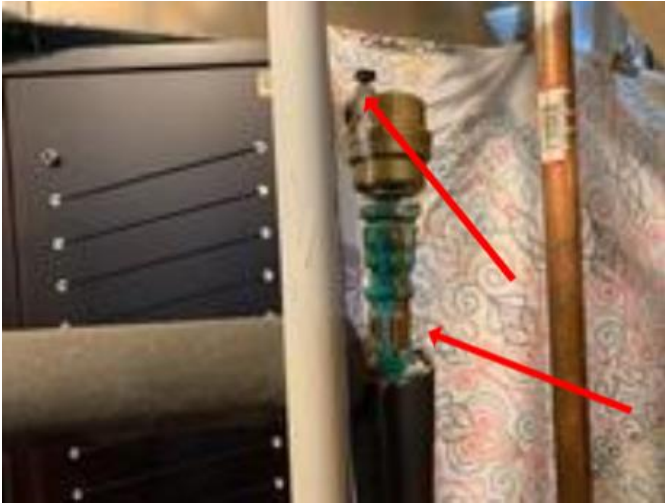
7.5) Water Heater Conditions 2**R**

The hot water tank safety relief valve shows corrosion. In its present condition, the valve can begin to leak causing the valve to not operate as designed. Seek the advice of a qualified plumber to repair as necessary.

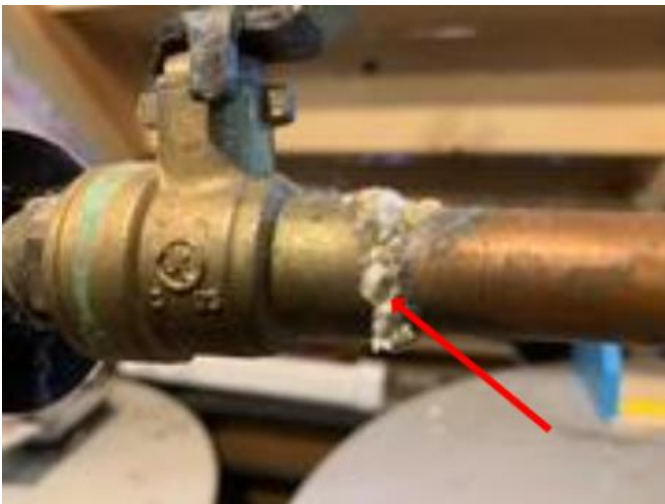
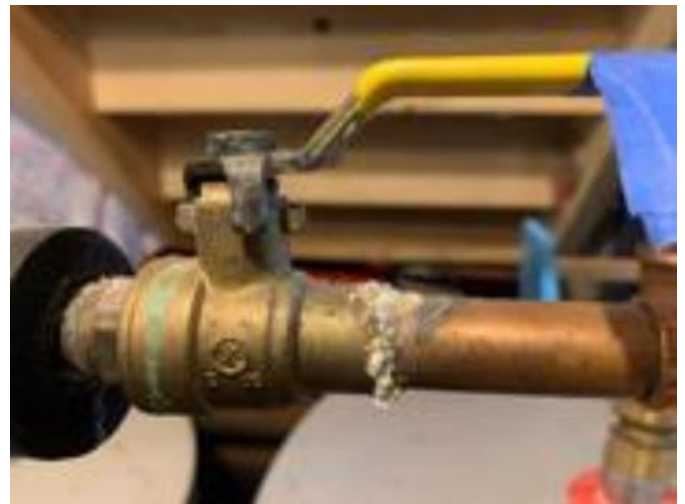
7.6) Water Heater Conditions 3

The hot water tank valve shows corrosion. In its present condition, the valve can begin leaking at any time. Seek the advice of a plumber to repair or replace as necessary.

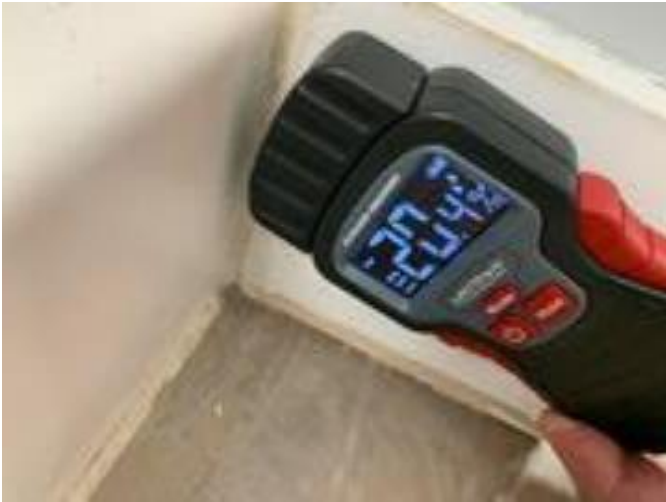
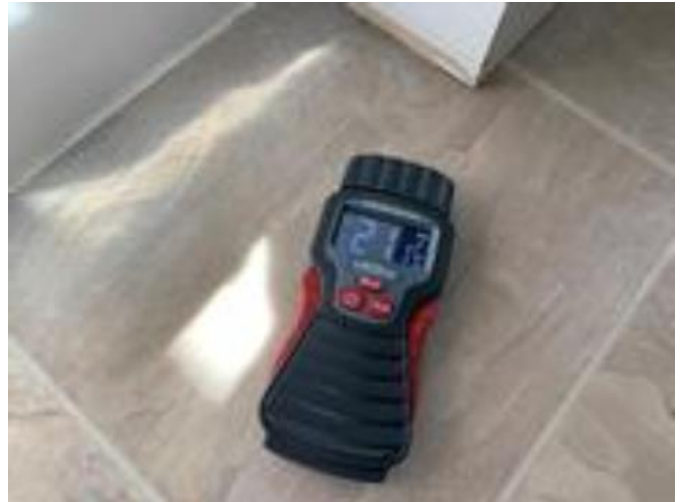
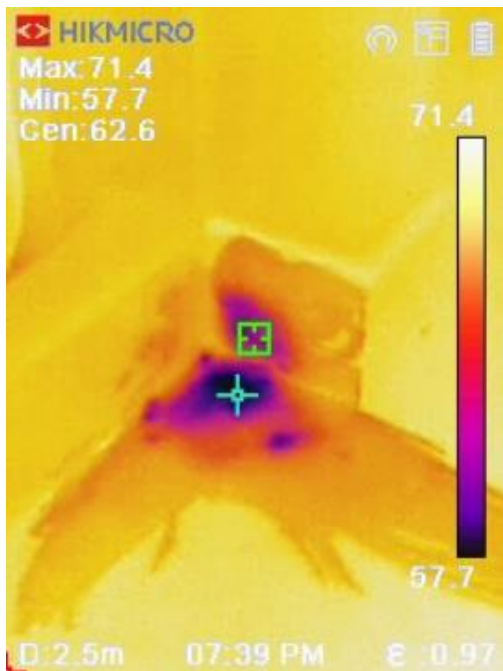
| Caulking (Repair) | 9.9 | The master bath shower area has deteriorated and missing caulk. A thermal image was taken and the floor area was tested with a moisture meter and showed excessive moisture. In its present condition, the opportunity is present, over time, for damage. Seek advice to repair as necessary. |

The master bath shower area has deteriorated and missing caulk. A thermal image was taken and the floor area was tested with a moisture meter and showed excessive moisture. In its present condition, the opportunity is present, over time, for damage. Seek advice to repair as necessary.

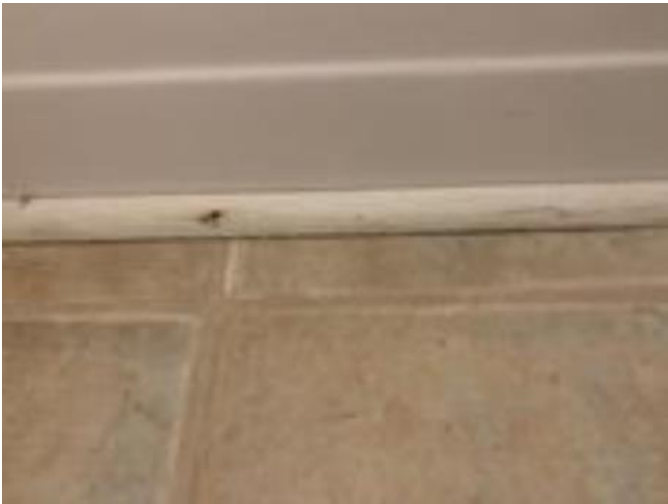
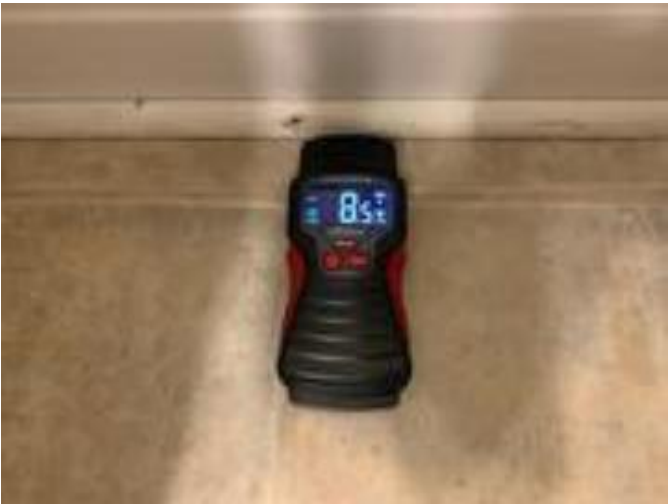
| Caulking (Repair) | 10.9 | There is no caulk present at the base of the tub. This area, at the present time, shows no excessive moisture, however, caulking is recommended to prevent the opportunity for moisture damage. |

There is no caulk present at the base of the tub. This area, at the present time, shows no excessive moisture, however, caulking is recommended to prevent the opportunity for moisture damage.

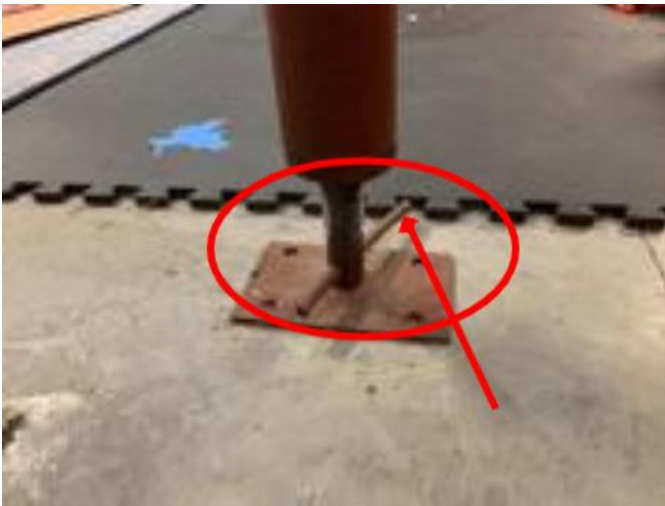
Other Conditions**13.10) Other Conditions****M**

| Other Conditions (Monitor) | 13.10 | Adjustable screw jacks were present. Typically, these are used as a temporary installation with no footing support under the screw jack columns. Although we observed no obvious evidence suggesting imminent instability as a result of this condition, permanent steel post or block support with footings under would be proper considering today's standards. Client should consult with a contractor for additional information. |

Adjustable screw jacks were present. Typically, these are used as a temporary installation with no footing support under the screw jack columns. Although we observed no obvious evidence suggesting imminent instability as a result of this condition, permanent steel post or block support with footings under would be proper considering today's standards. Client should consult with a contractor for additional information.
